# NOT ALL IS AS IT SEEMS

Reinvestigating A Persistent Benzene Plume Using HRSC

Emma Walsh, Graeme Miller, Michelle Agnew

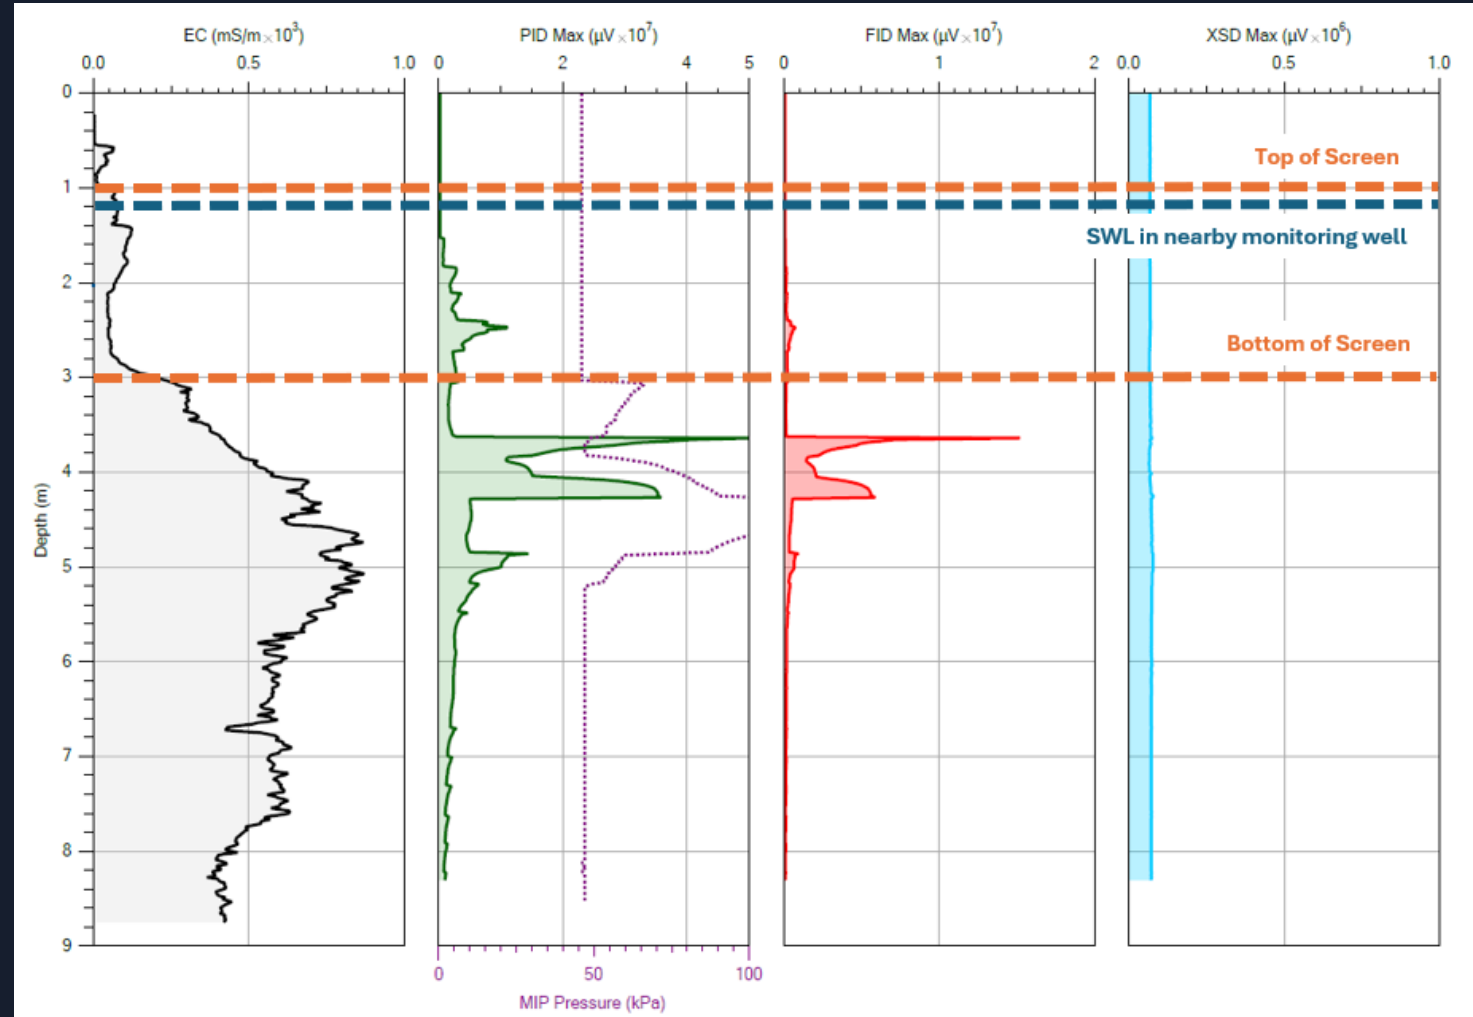
# Stage One – What did the MIP Show?

- Contamination deeper than previously reported.
- Highest PID responses at base of northern embankment – indicating plume extended north of prior remediation area.

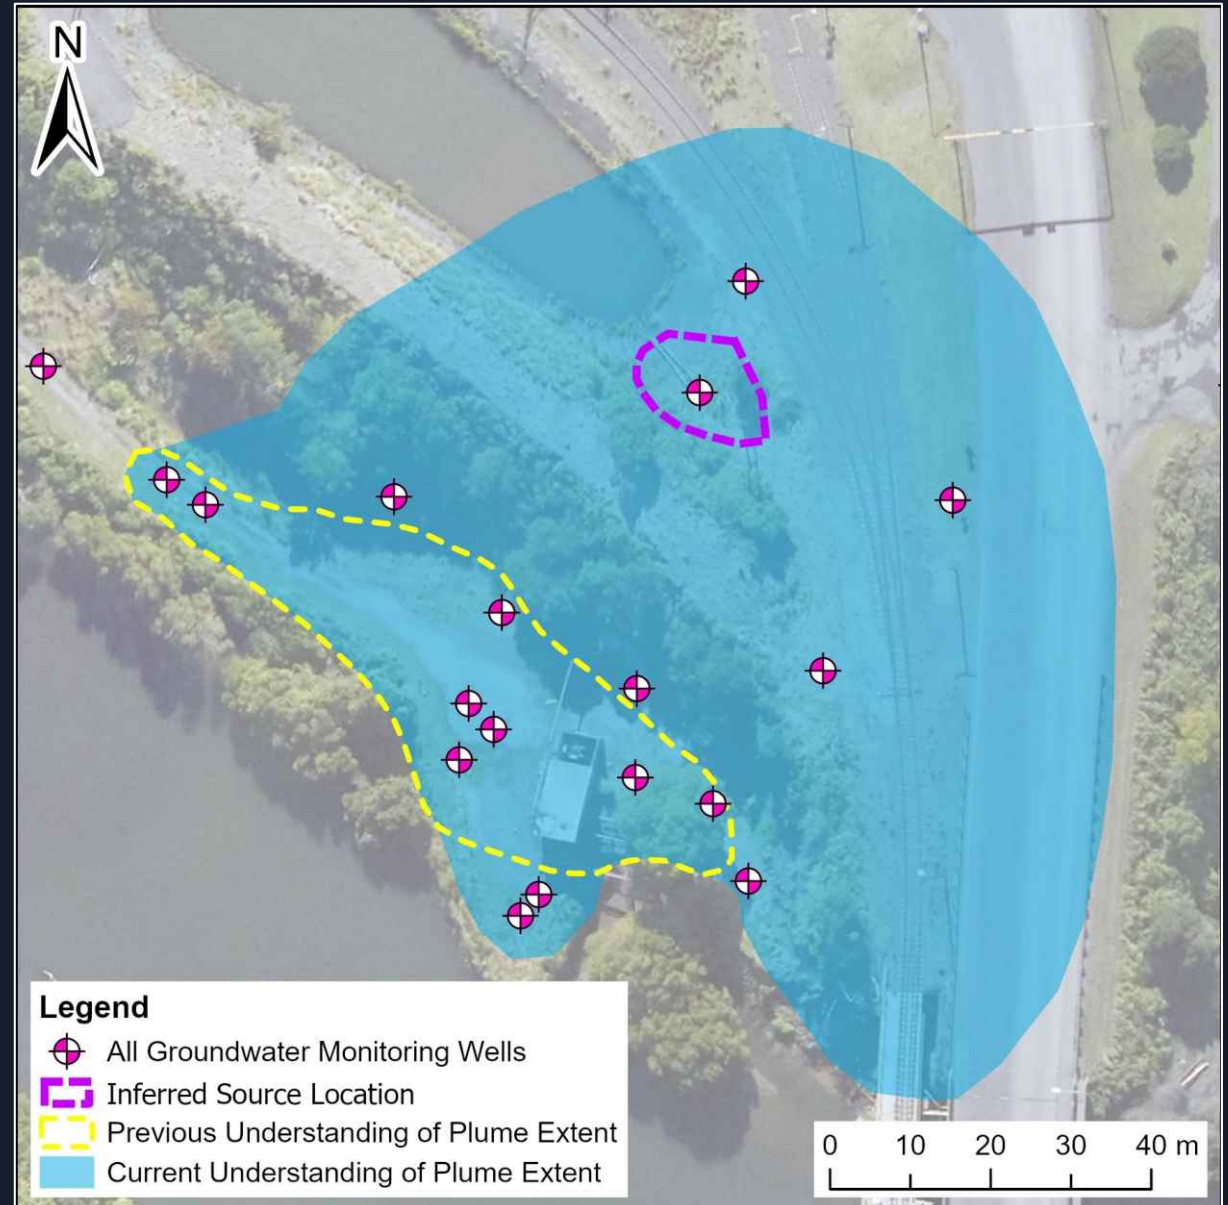
Combined results from MIP HRSC and verification assessment indicated that:

- Soil and groundwater contamination exists at depths below the previous remediation
- Source area identified outside of previous remediation area.
- Contamination extends significantly further north and east.
- New CSM reflects greater extent of plume
