# Remediation of CVOCs in a Residential Area by Electrical Resistance Heating

## 2024 Chlorinated Conference

Bruna Pioli, Amanda Basaglia, Diana Chang, Marcelo Altafini - BTX  
Geologia e Meio Ambiente; Thiago L. Gomes - TRS Doxor, Jacob Seeman  
TRS

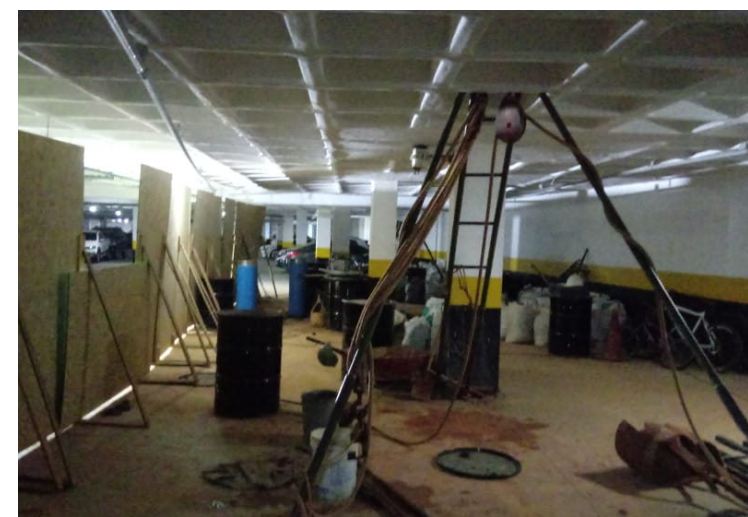
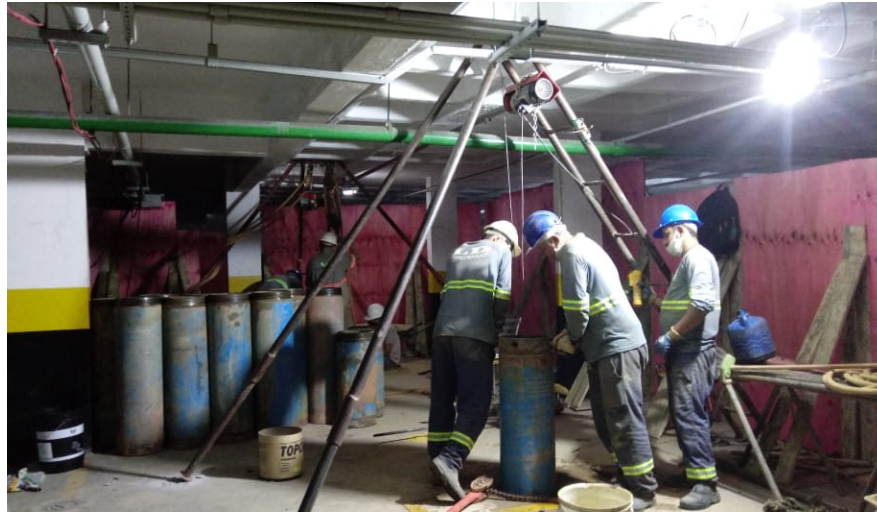
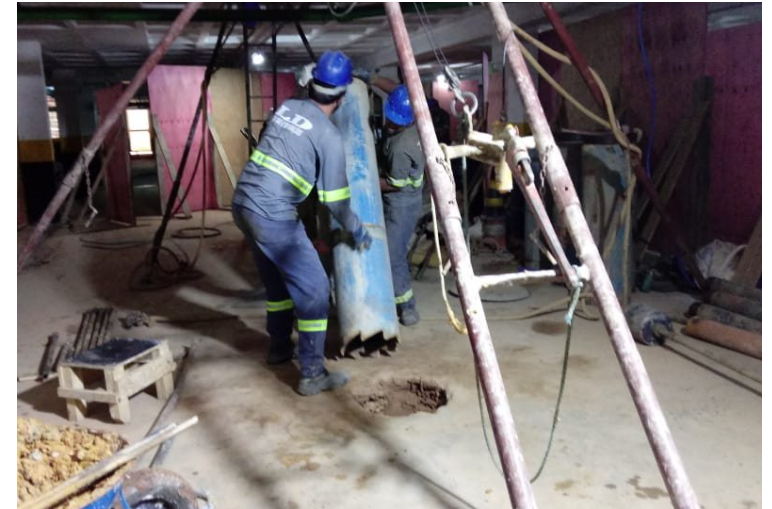
- ELECTRODE BOREHOLES

- Low ceilings
- Isolation of the area
- Clay soil was extremely difficult to drill in

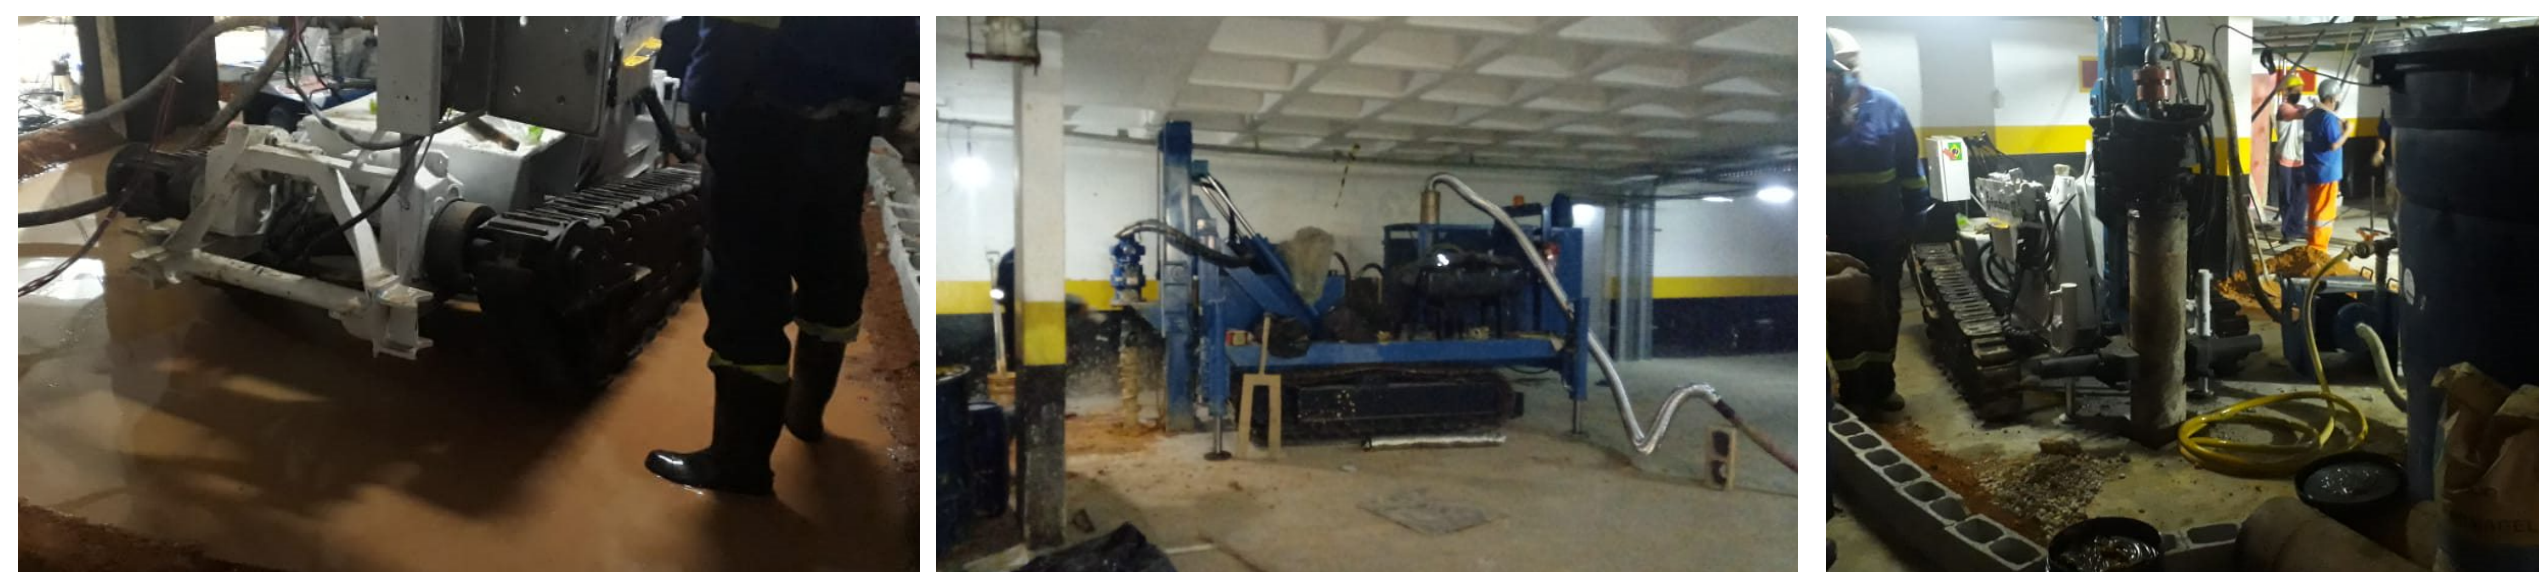
## • ELECTRODE BOREHOLES

- Mobilization of the Hollow in the garage
- Isolation of the area
- Generation of drilling spoils
- Exhaust fumes management
