June 6, 2024 | 3:30 p.m.  
Battelle Chlorinated Conference

# Remediating HARMFUL ALGAL BLOOMS

Evaluation of Aluminum Sulfate (“Alum”) Dosing to  
Remediate Harmful Algal Blooms in Reservoirs

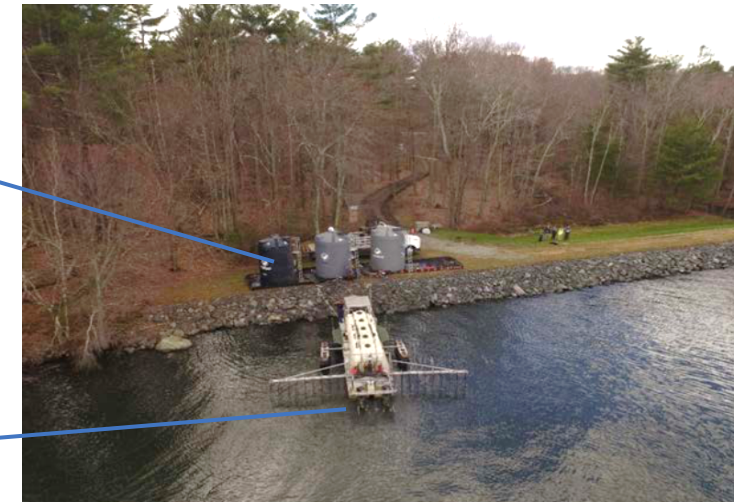
Staging area, chemical storage tanks, and treatment vessel on April 26, 2018.
