# IDENTIFICATION AND ENHANCEMENT OF NATURALLY-OCCURRING IN-SITU AEROBIC METABOLIC BIODEGRADATION OF 1,4-DIOXANE

**Kristi Diller (Parsons, CO)**

June 6, 2024

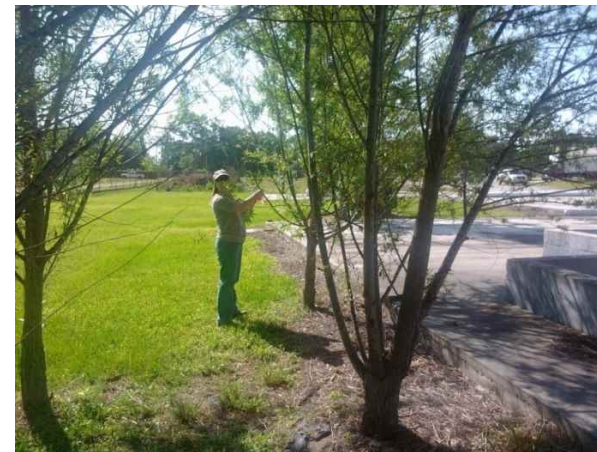
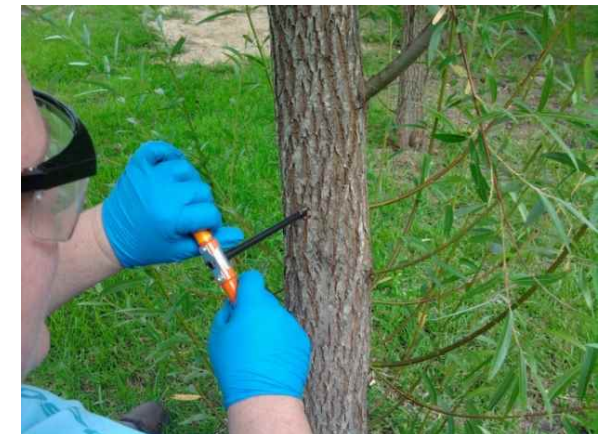
# PILOT STUDY HISTORY

- In 2011 and 2012, tree core analyses showed that 1,4-dioxane was being taken up by phytoremediation trees and native trees
- Groundwater concentrations not significantly reduced
- Trees likely only taking up groundwater at the water table interface
