# **Lessons Learned: A 20-Year Review of the Effectiveness of Containment Barrier Walls in the Pacific Northwest**

**Trevor Louviere, P.E.** (DOF – Dalton, Olmsted & Fuglevand)

**Battelle 2024 Chlorinated Conference**

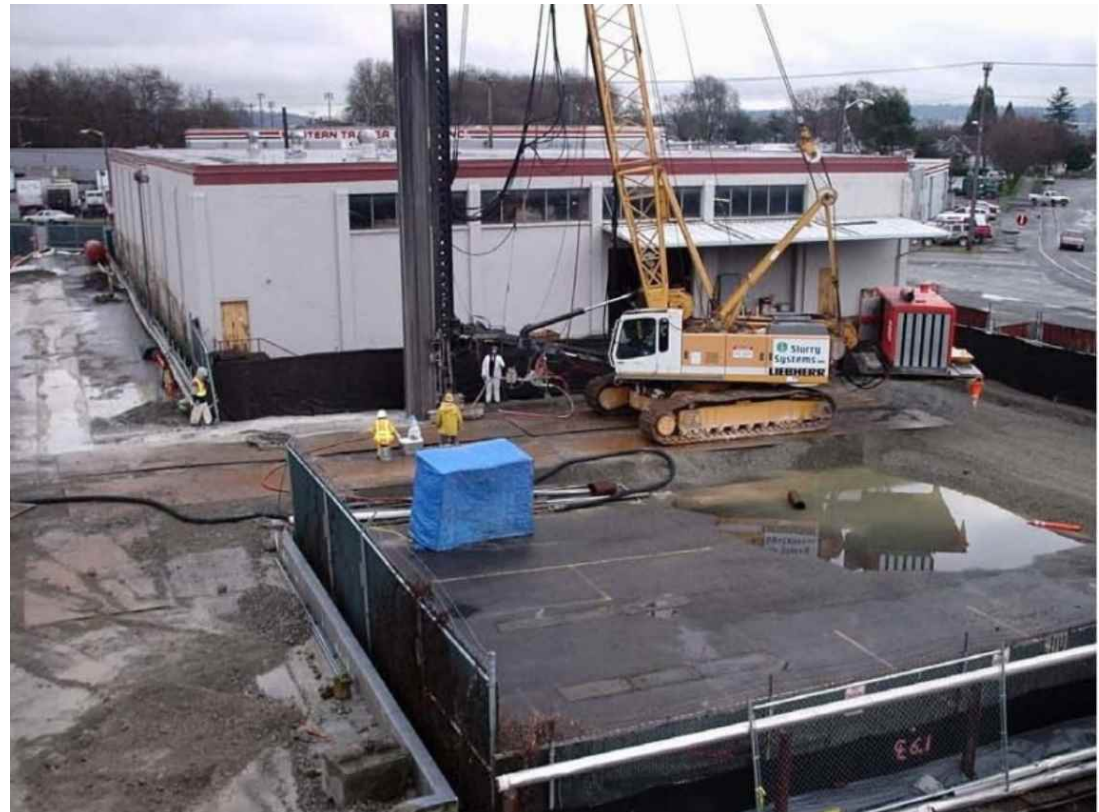
# Commonalities Between Barrier Wall Example Sites

- Vibratory Beam installed barrier walls
- Walls constructed from Attapulgate clay and slag cement
- Average thickness of 6-inches
- Both walls installed between 2002 and 2003
- Includes hydraulic control via low flow groundwater extraction governed by a minimum inward hydraulic gradient standard
