# Manners Piece: Getting to the Last Bite of Contaminant Mass Through Fracture Emplacement

Marc Killingstad

June 5, 2024

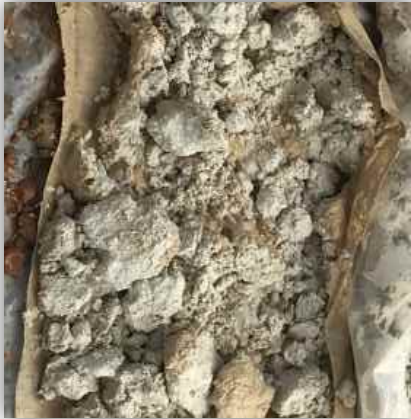
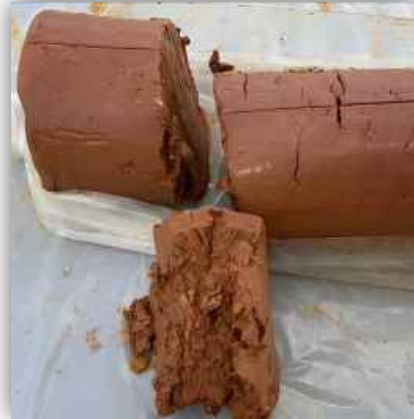
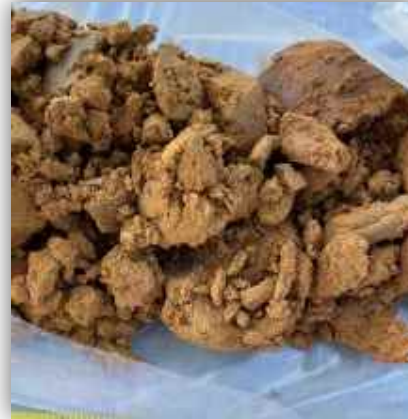
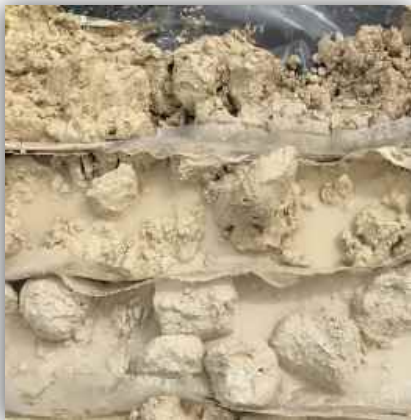
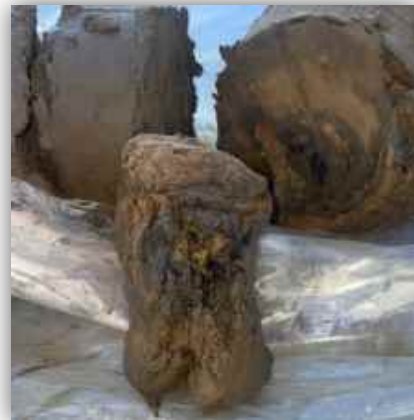
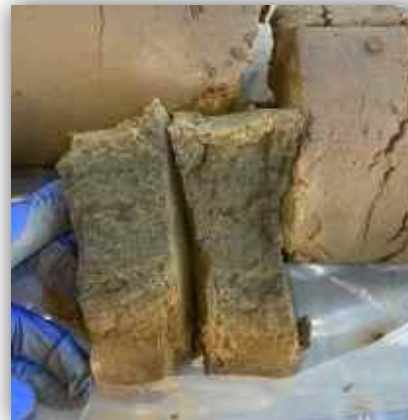
- Coastal Plain Province
- Residual soil to ~40 ft bgs; clayey sands/sandy clays w/ thin clay layers
- *Dark brown plastic clay at base of residuum*
- Ocala Limestone: soft, poorly cemented with cavernous zones 60-80 ft thick, more competent with depth (>100 ft bgs)

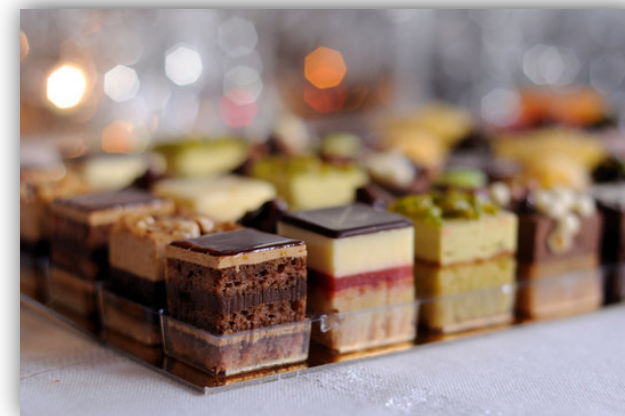
- **Mignardise:** Fracture-enhanced biosphere within clay to grab the 'last bite'

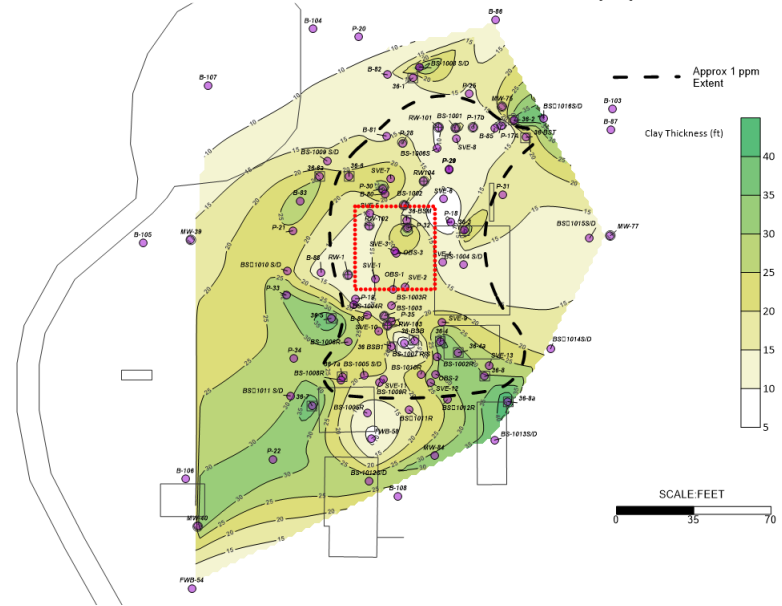
SWMU 36 ESTIMATED THICKNESS OF CLAY (FT)
