## **Subfloor Tunnels and Floating Slabs in a 7-acre Building The Case of the Accidental VI Mitigation System(s)**

**Battelle 2024**

**Joshua Ryncarz, Vitthal Hosangadi, Scott Lowe,  
Nicholas Shih**

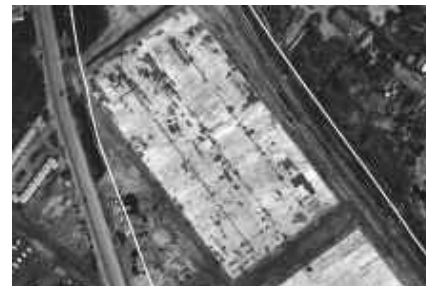
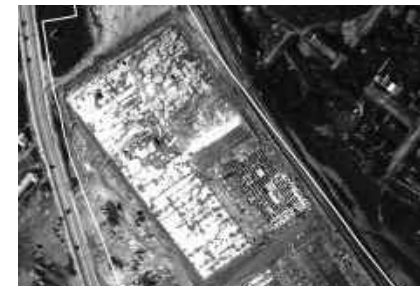
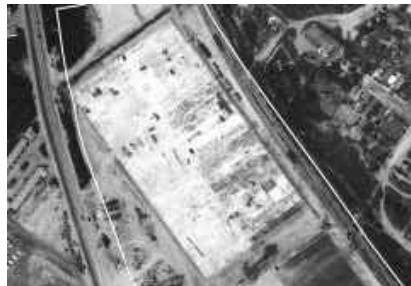
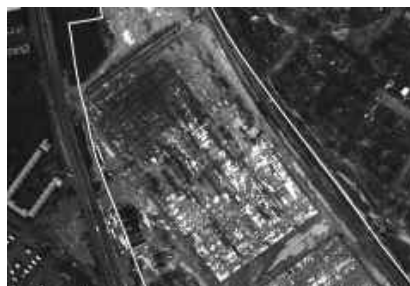
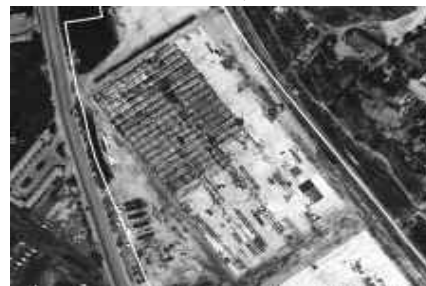
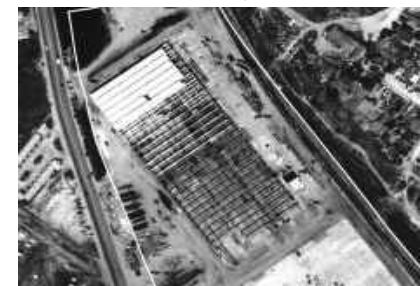
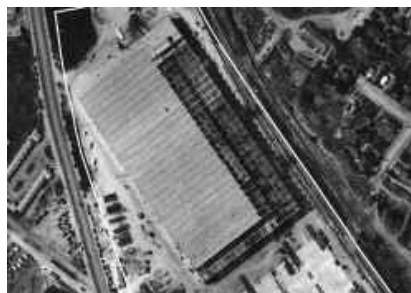
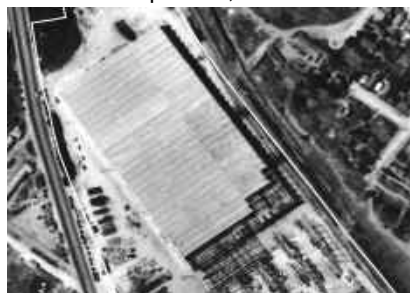
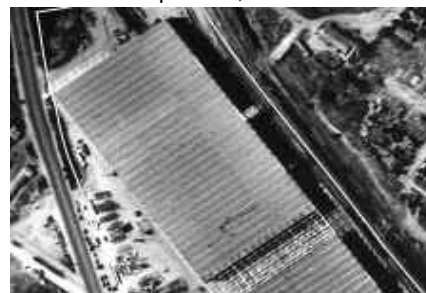
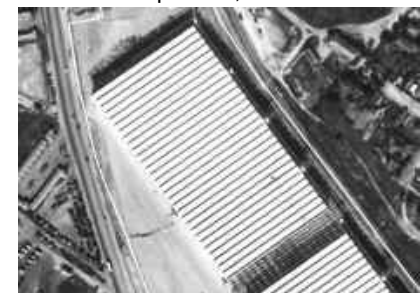
The land was formerly a floodplain of a nearby river and had to be stabilized with dredge and imported fill prior to construction from 1940 - 1941.

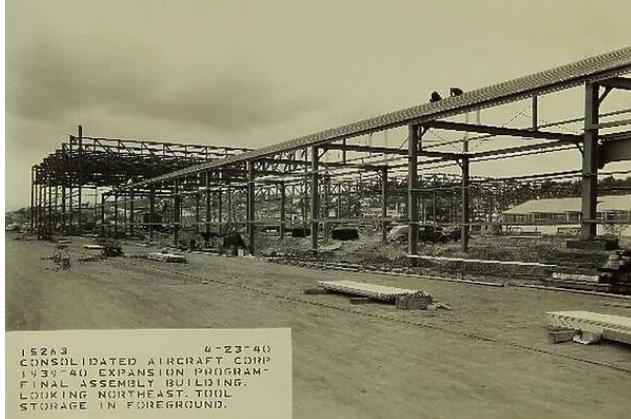
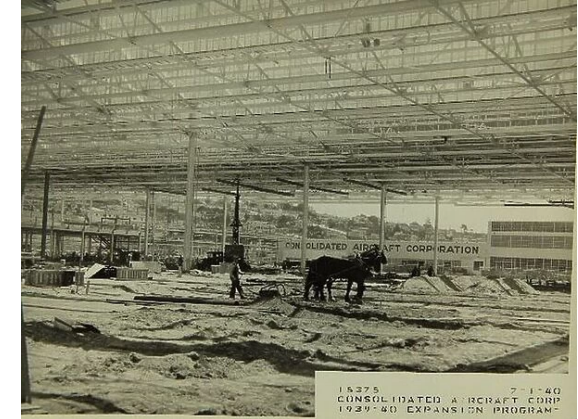
## 3.1 Building Design and Purpose

- Building footprint is ~ 300,000 Square Feet (~ 7 acres)
- Built during World War II
- Used for the manufacture of warplanes (production of 270 B-24 Liberator bombers per month during World War II)
- Steel I-beams used to frame and anchor the warehouse
- Multiple buried vaults, utility corridors throughout

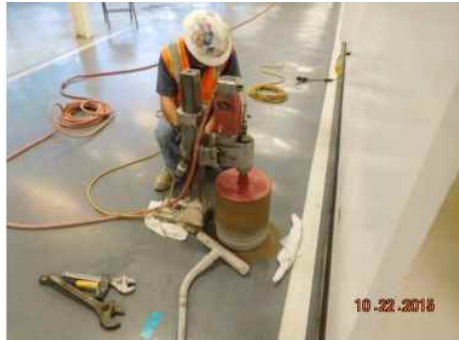
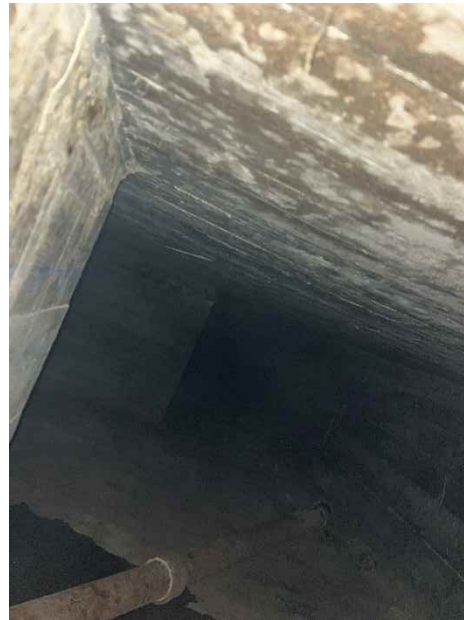
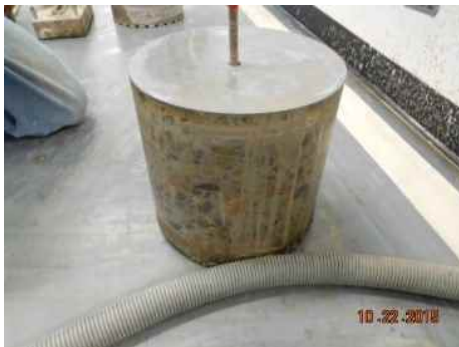
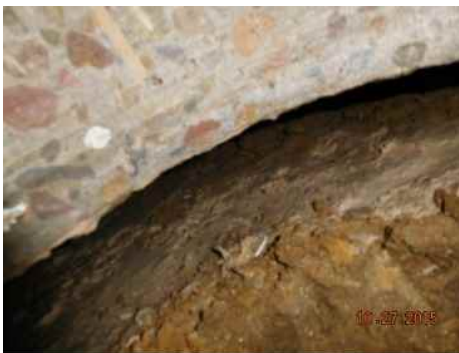
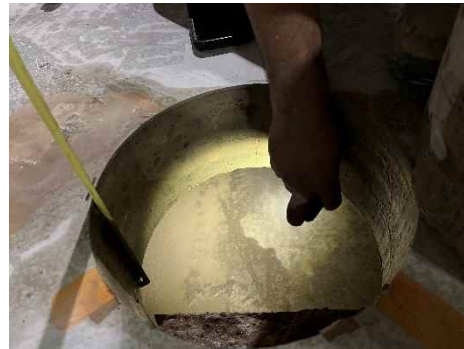
## 5.1 A Building that Floats

- SVE Pilot Test conducted in 2014
- None of the subfloor probes near the extraction well showed a vacuum response
- **The team realized that there was an air gap below the floor**
- The air gap was connected to multiple vaults and utility corridors; and was the key VI Pathway
- A helium tracer test was performed and established an ROI of at least 181 feet
- This confirmed the air gap is connected underneath the Building

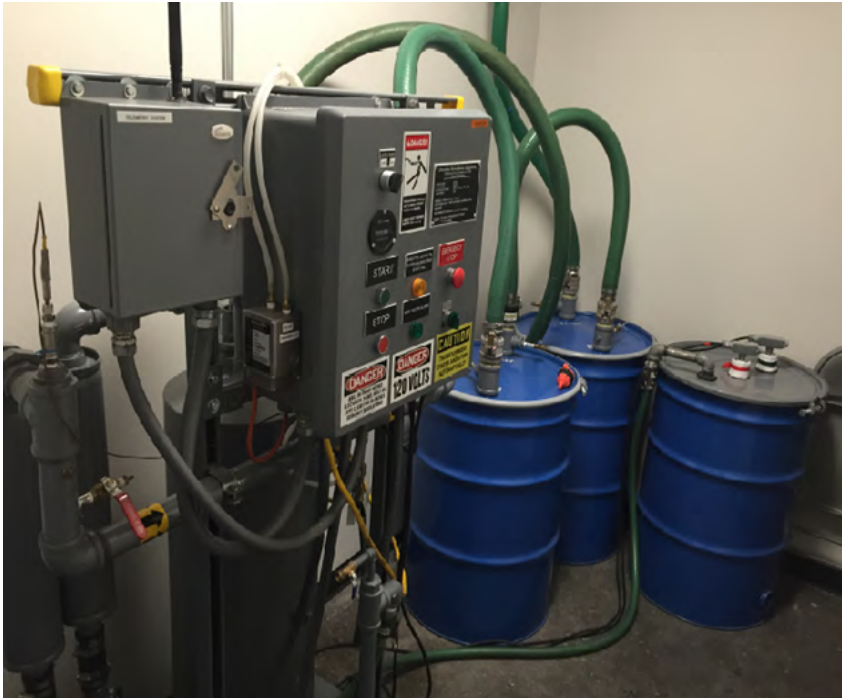
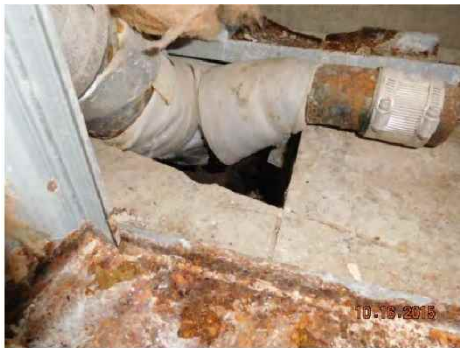
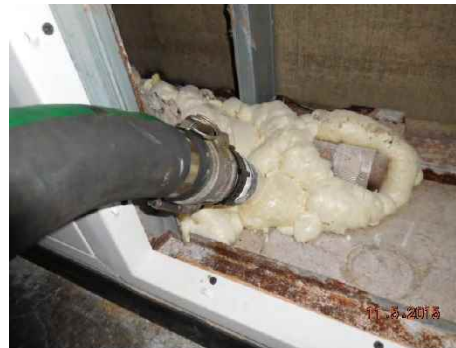
## 5.2 North VIMS Design (Installed February 2016)

- One of the closets near known soil gas contamination had an opening in the wall, leading to an apparent cavern
- The cavern was connected to the air gap
- Instead of using the SVE wells installed for the SVE Pilot Test, a slotted pipe was inserted into the opening, and a seal was placed around it
- The well was connected to a vacuum blower and VPGAC (at a fraction of the cost of a typical VIMS for an area this size)
- VIMS continues to operate as of 2024

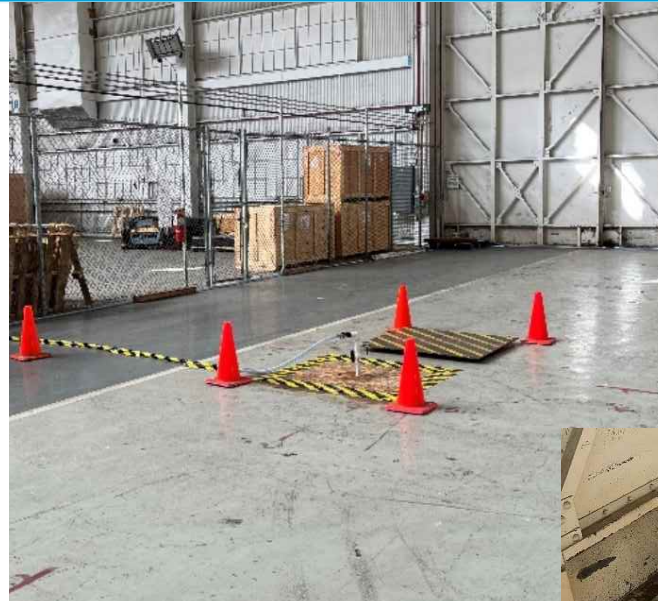
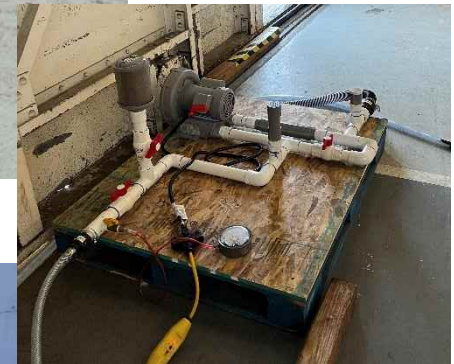
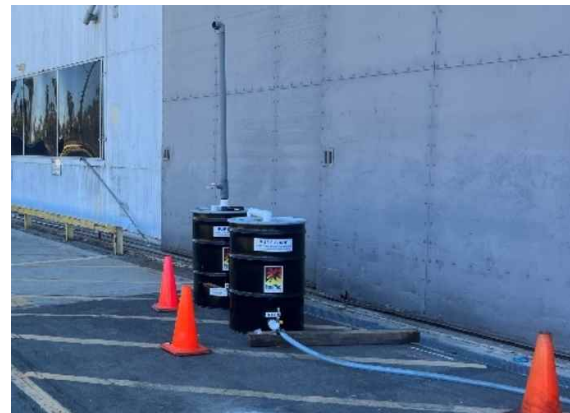
## 5.5 South VIMS Design (Installed June 2022)

- In early 2022, TCE was detected in the air gap in the southern part of building at  $140,000 \mu\text{g}/\text{m}^3$
- Given the experience with the northern VIMS, the team found a vault close to the highest contamination
- A temporary VIMS was constructed in only a few days for an immediate response until full scale system could be implemented (parts were mostly sourced from a local Grainger)

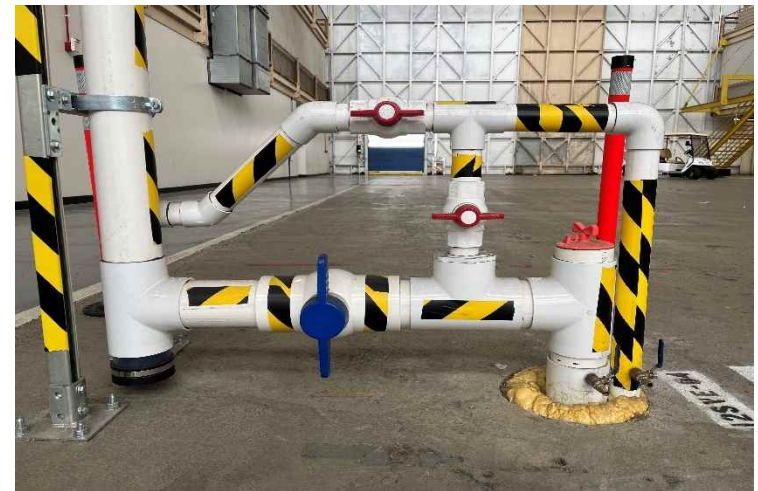
## 5.6 South VIMS and SVE Design (Installed May 2023)

- Permanent South VIMS constructed
- Soil gas contamination addressed with SVE system – SVE wells co-located with VIMS extraction points (isolated from air gap using seal)
