# Identification of new preferential pathways for vapor intrusion of chlorinated solvents found by combining VaporSafe™ and detection dogs

**Lena Torin**, Julia Inkapööl and Inger Johansson (WSP Sweden, Sweden)

June 4th 2024

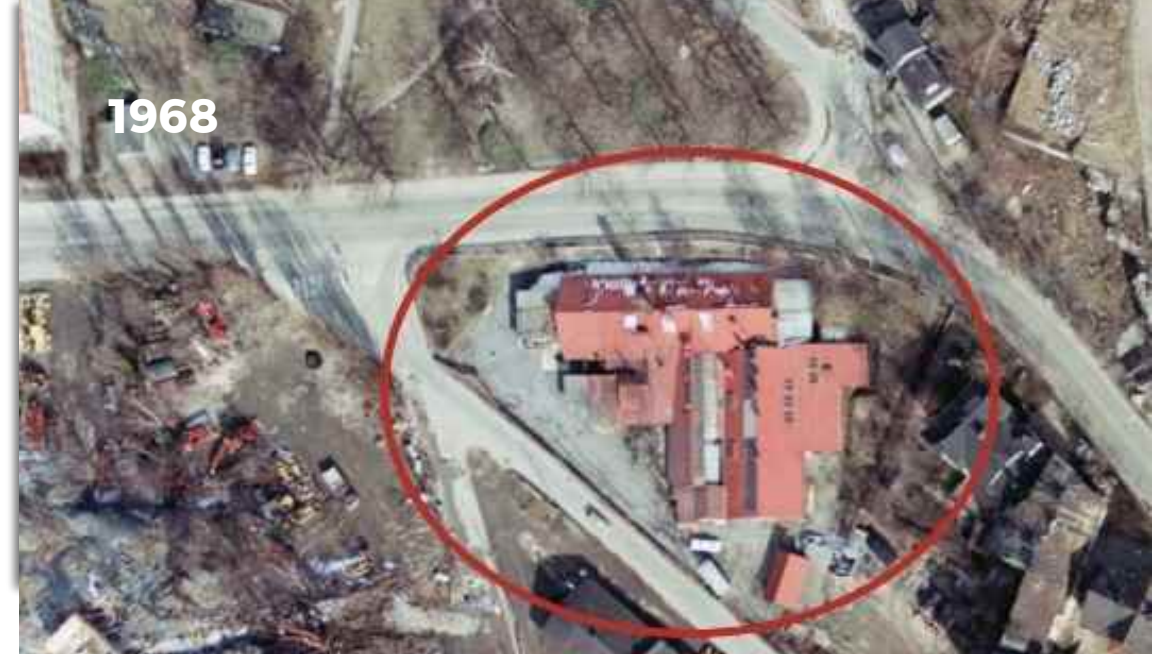
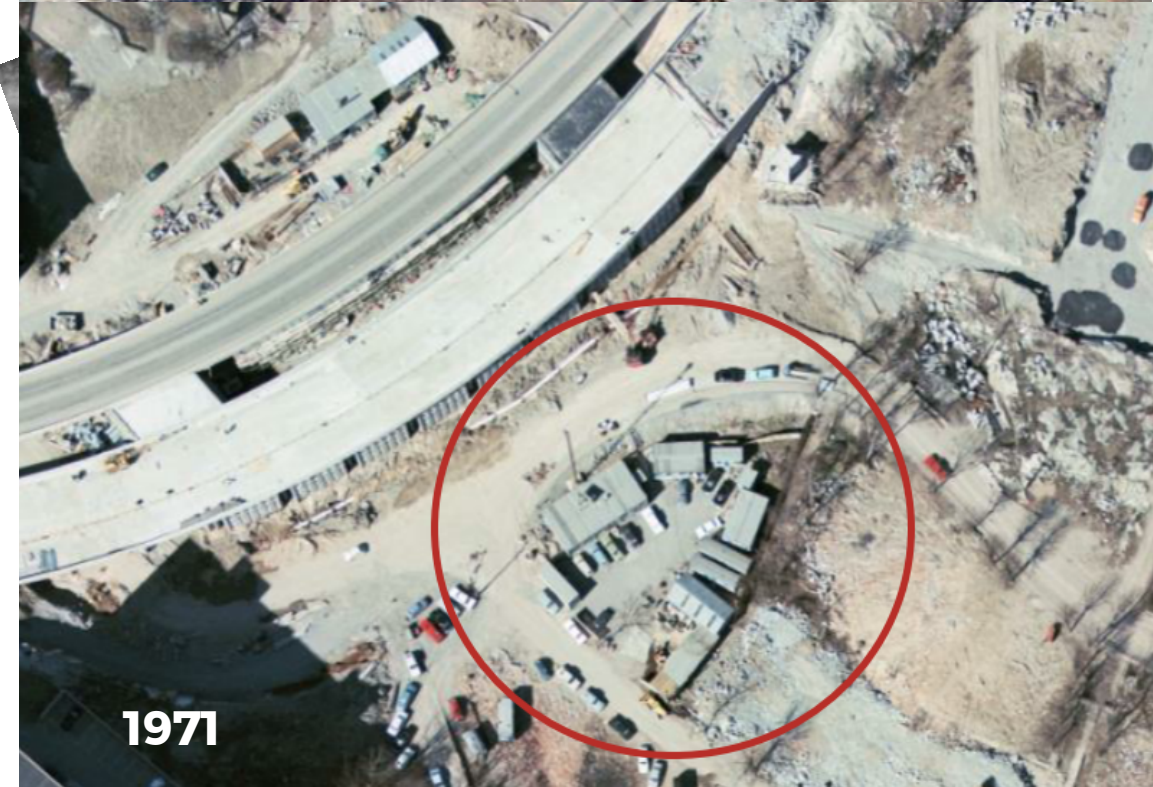
One of Stockholm's largest dry-cleaner

- Operated approx. 1940-1970
- Handled 500-1,000 tons TCE & PCE

After operations ended:

- Buildings were demolished
- Redevelopment with expressway on a viaduct with buildings below

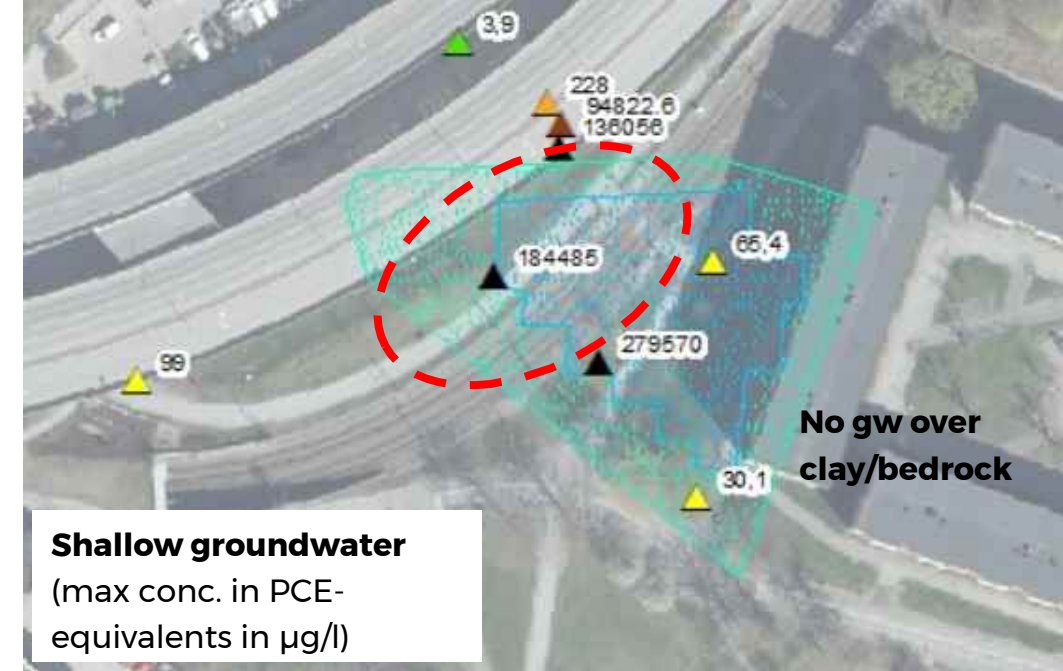
## Investigations: Plume in GW

### Localised shallow groundwater:

- Low conc. in gw (and soil) near the apartment building (< 70 µg PCE-equiv/l)
- High conc. under the vacant workshop

### Aquifer below clay:

- Plume in two directions with high conc.
- However, no deep aquifer near the apartment building

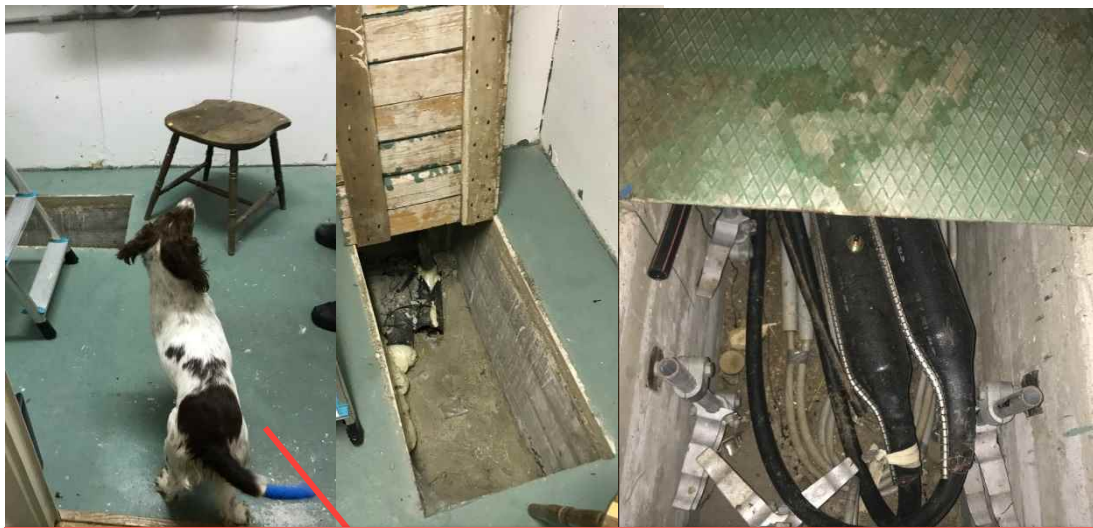
Identified focus areas for VaporSafe™:  
→ Lower basements and especially technical spaces in the west and south building

**New insight:** More than pipes can act as preferential pathways for VI!
