# Ebullition-Facilitated NAPL Transport: Case Studies where Screening Evaluations Changed the Remedial Path

Lisa Reyenga  
June 2024

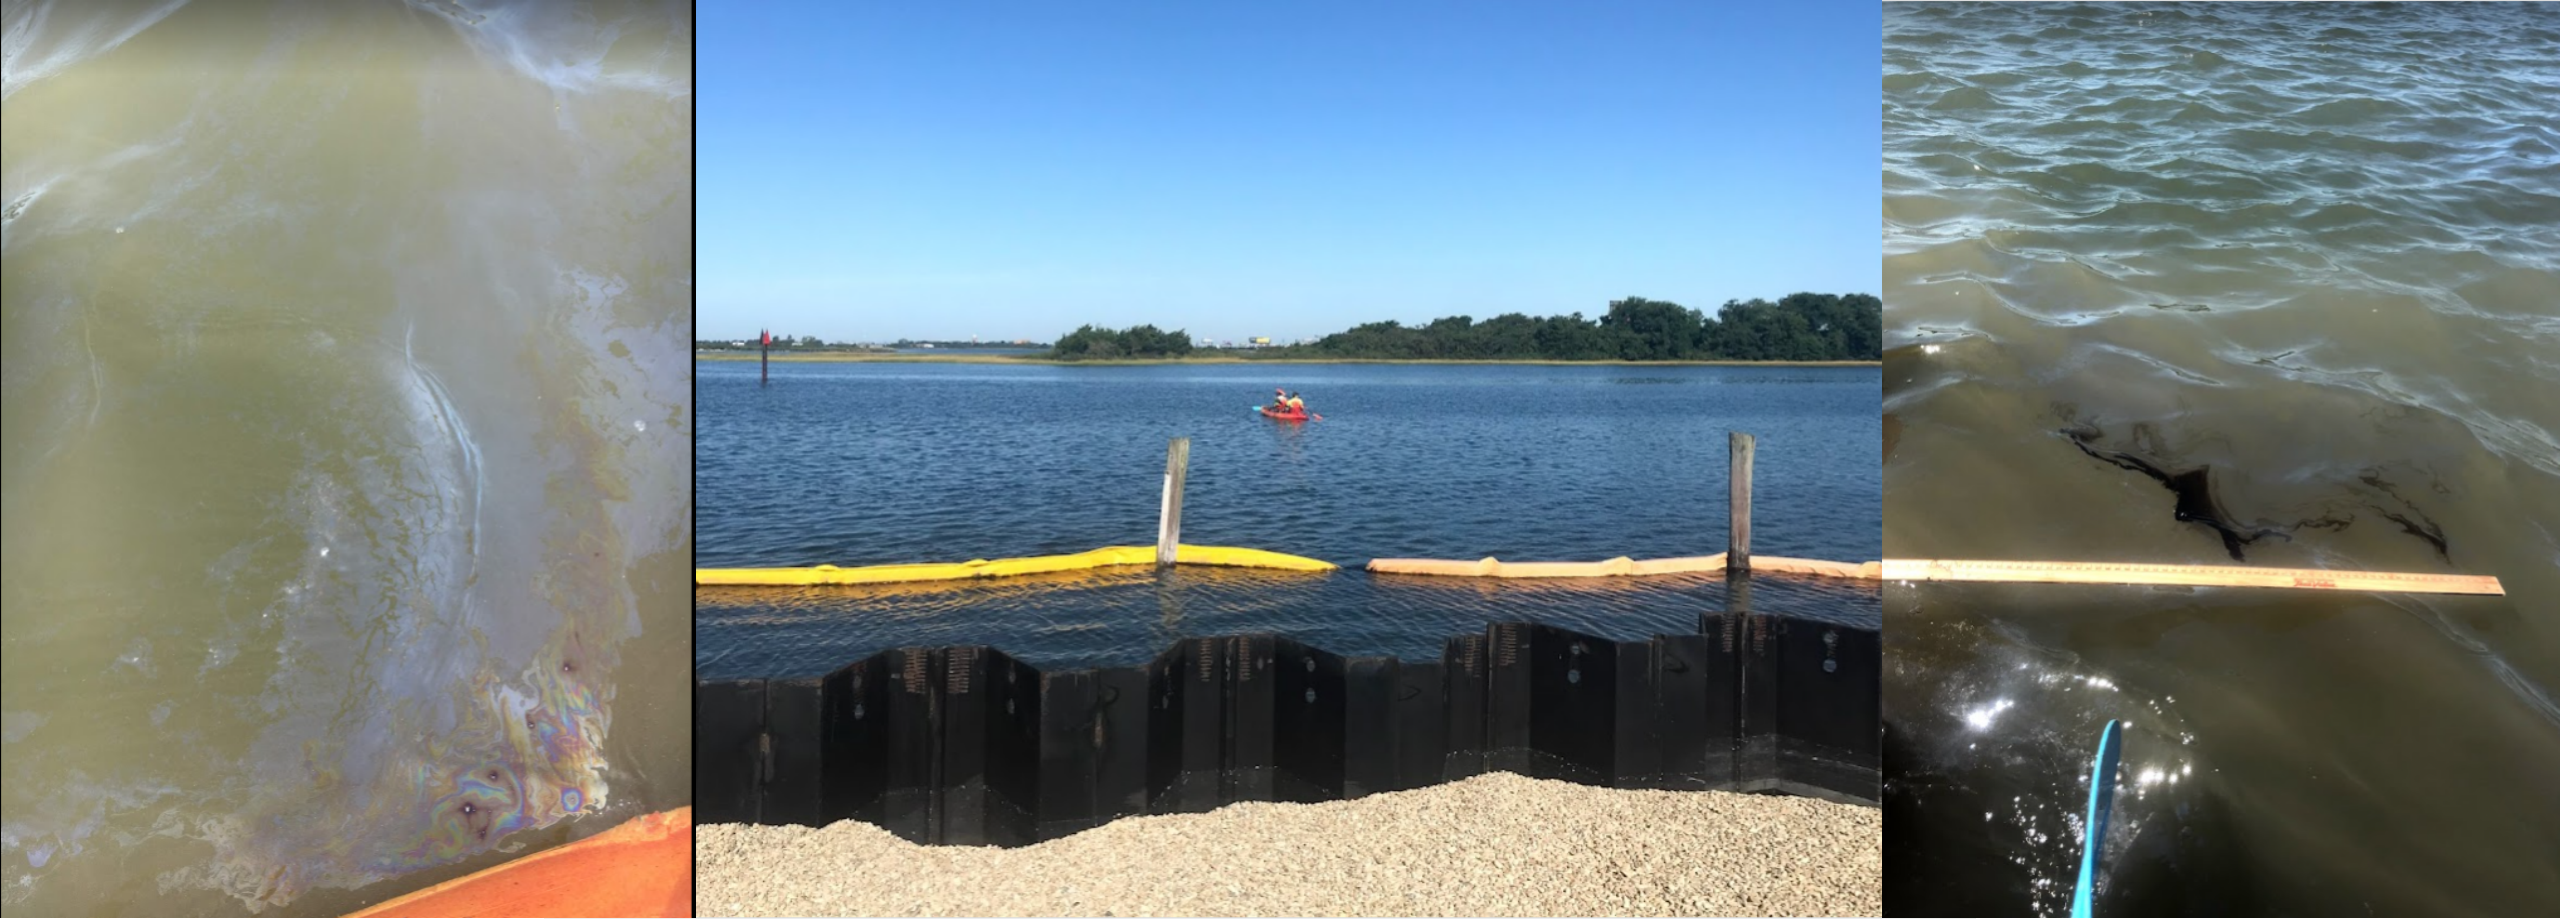
NAPL is present in sediment adjacent to a former MGP up to 30 feet below the sediment surface.

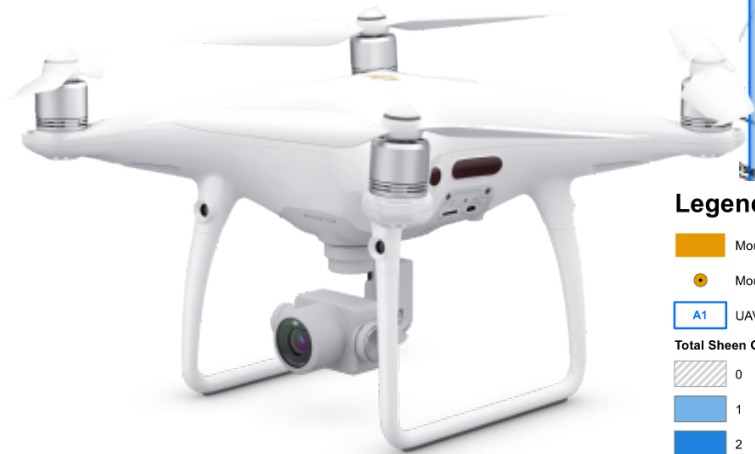
Sheens  
observed year  
round,  
predominantly  
in late summer /  
early fall.

Sheens  
observed  
throughout  
NAPL extent.

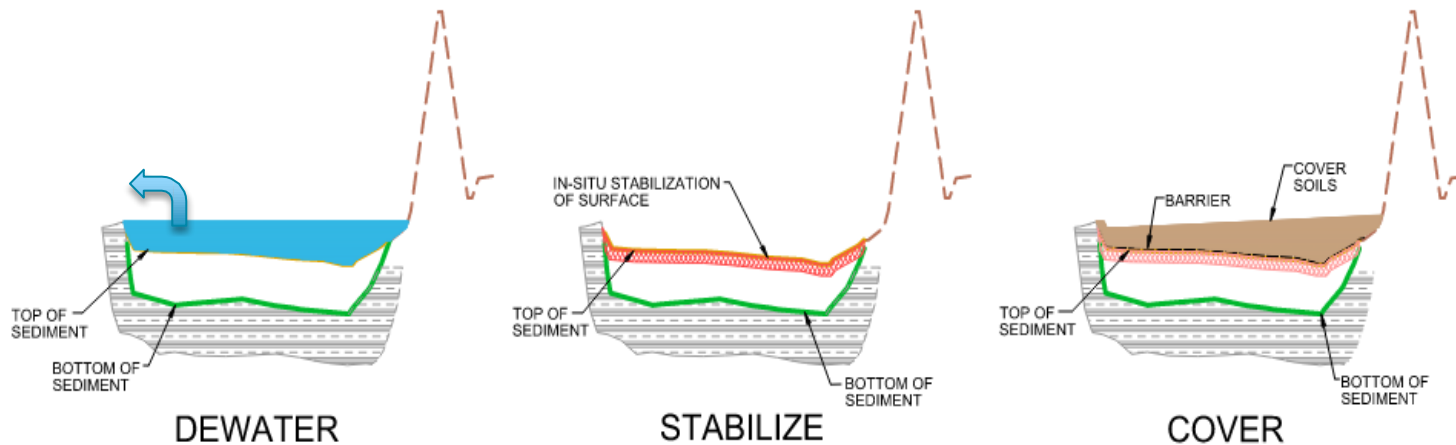
# Current Remedy: Dewater, Stabilize, and Cover

Erosion/Topsoil Layer

Infiltration Layer

Geomembrane

Stabilized Sediments

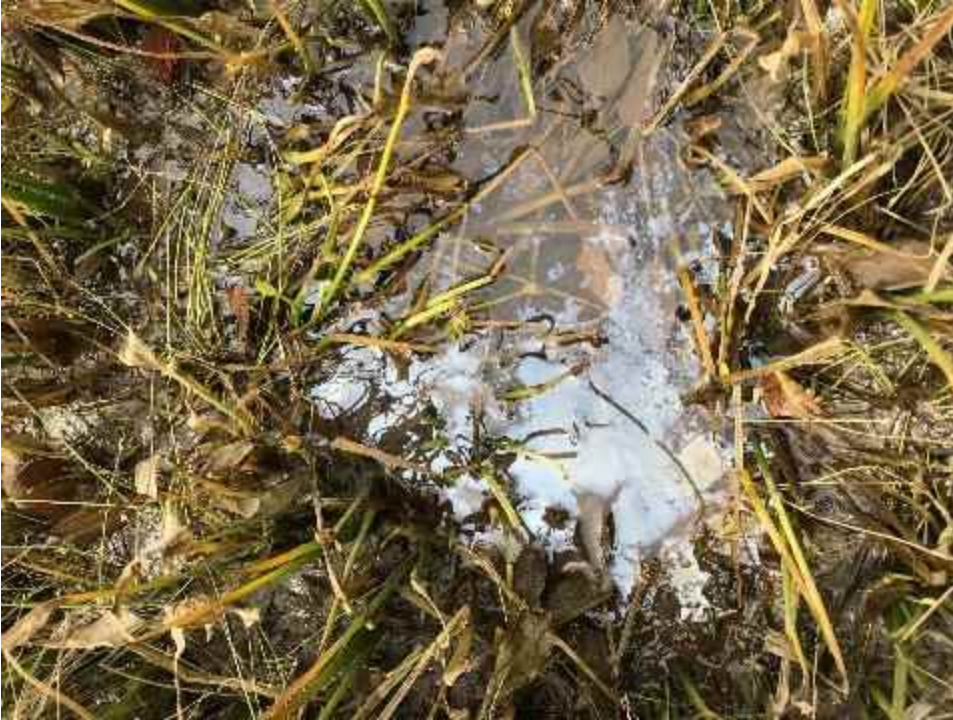
Ebullition had been documented as a potential concern in the mudflat areas.
