# Challenges of Conducting an Environmental Site Investigation in Aquifers with Low-permeability Zones

**RAMBOLL**

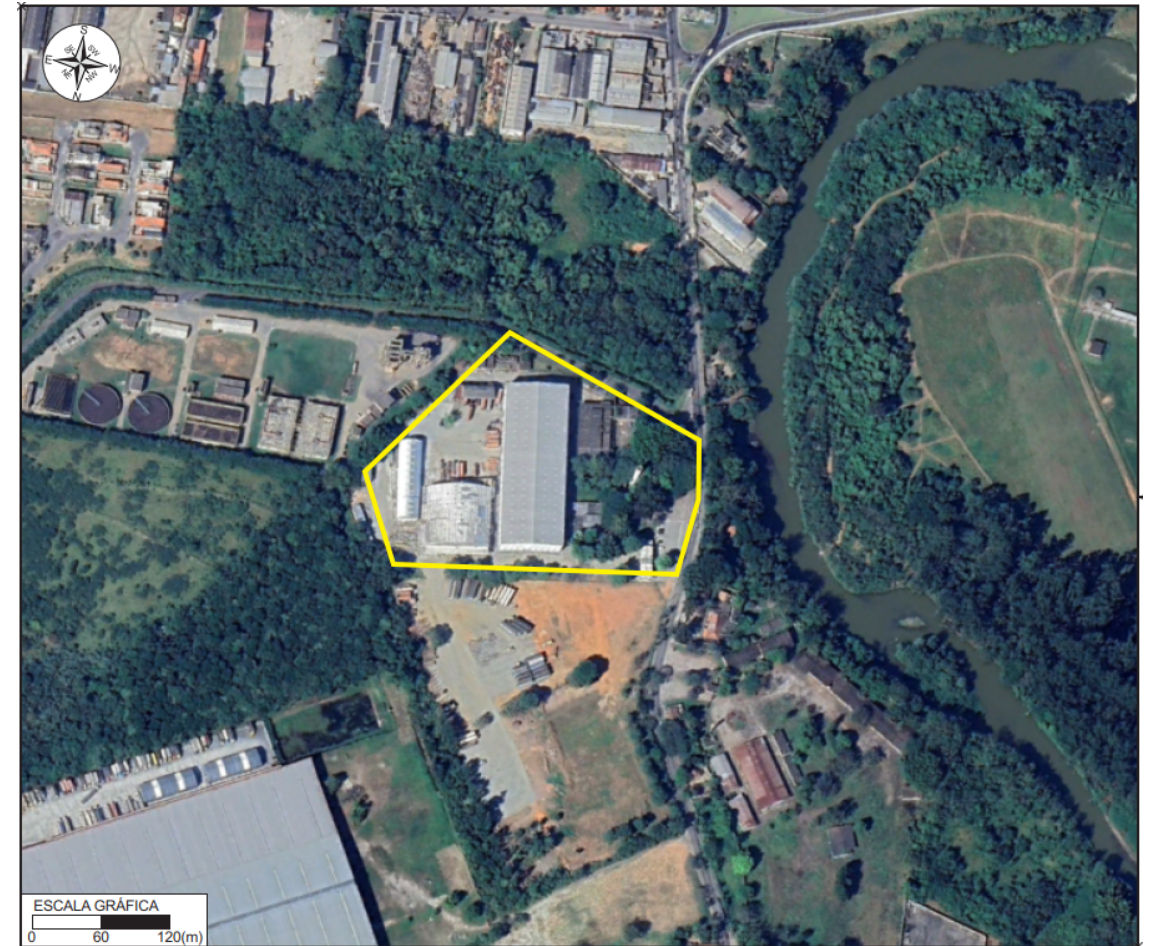
- Former **industrial activities** involving **tyre valve manufacturing for the automotive industry**, including **rubber production**, cleaning of parts, adhesive, application and vulcanization of rubber, assembly of the core valves.
- The former factory facilities cover a total area of 45,000 m<sup>2</sup>, with approximately 17,000 m<sup>2</sup> of built or paved areas.
- Main areas of interest: **Former Degreasing Room** (AS-07) and **Former Galvanizing Area** (AS-08): used from the 1980s until 2013 for degreasing operations, use of Tetrachloroethene (PCE); and electroplating, which involved the use of chromic acid.
- Currently, the area of study (the former production areas) is occupied by a **logistics warehouse**.

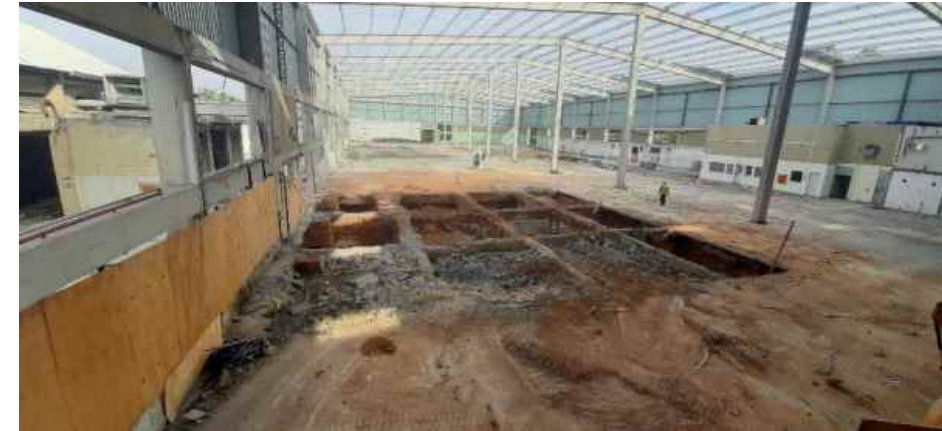
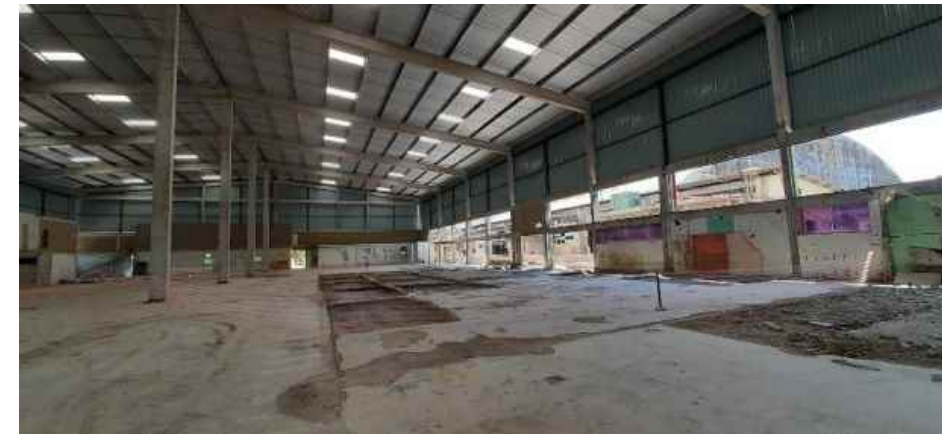
## Source Area Soil Excavation (2020)

- Excavation total area of **450 m<sup>2</sup>** at **3.0 meters** depth
- Excavated total volume of **1,887 m<sup>3</sup>**
- Excavated total soil mass of **2,464 t**
- Soil treatment: thermal destruction by co-processing

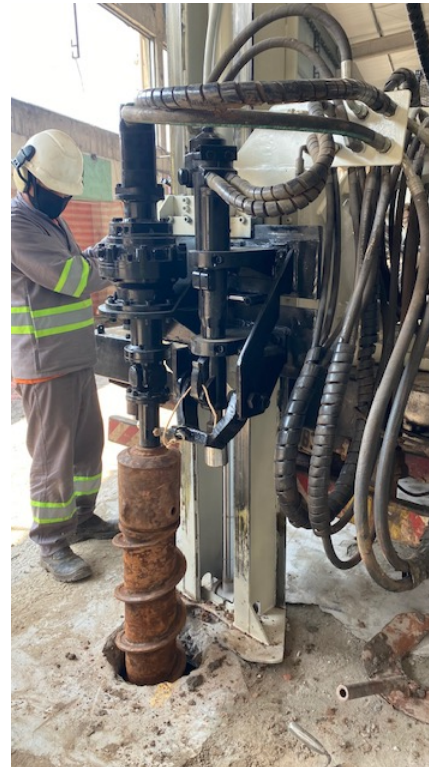
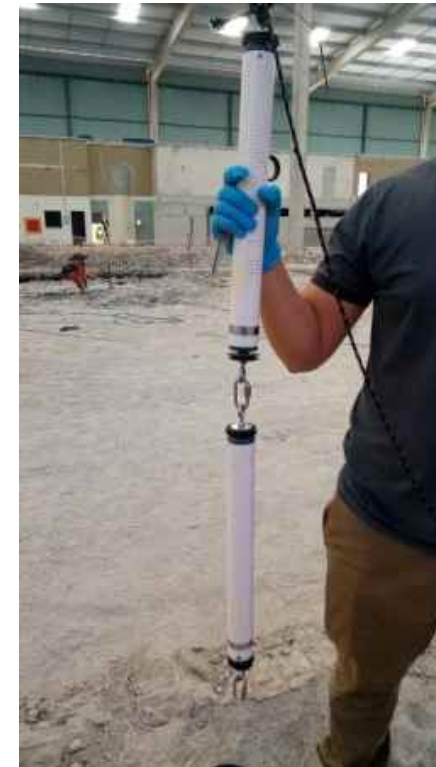
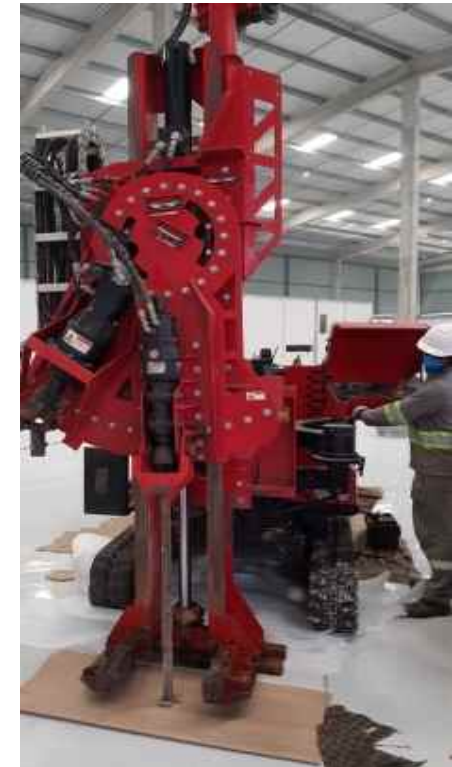
## Remediation Preliminary Tests (2021-2022)

- Pumping Well installation (PB-01) for **hydraulic tests**;
- Installation of **Biotraps** to evaluate the applicability of the bioremediation technique;
- Chemical Analysis for QuantArray-Chlor (DNA) and DHC functional genes in the Biotraps samples;
- **Treatability Tests** for ISCR using ZVI and Sodium lactate amendment;
- **Pilot Test** for ISCR – Direct Push Injections in 3 locations downgradient of source area.

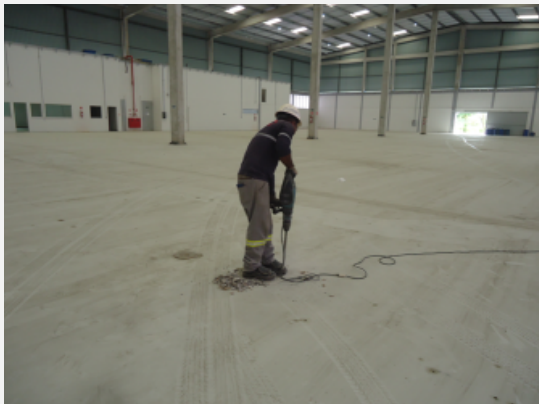
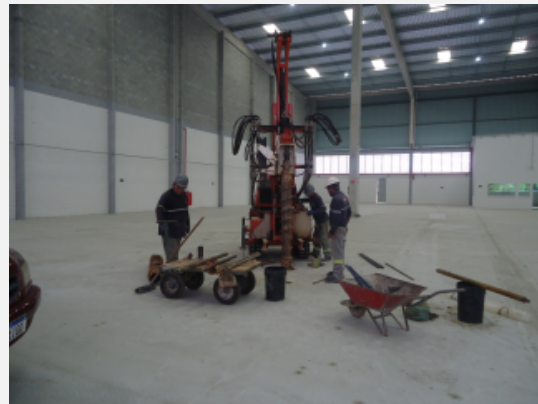
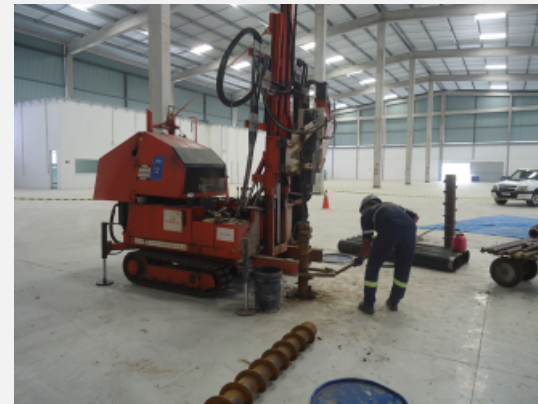
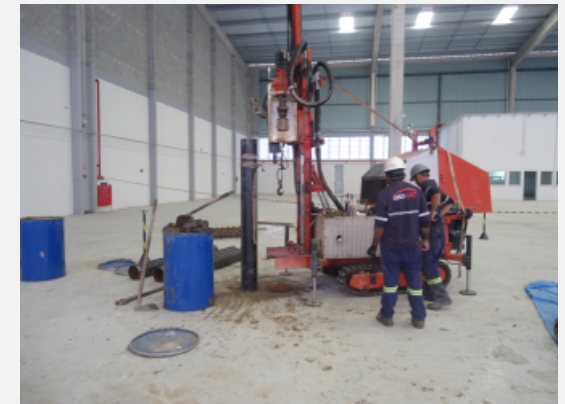
- Drilling of **20 soil boring**

(6.0m up to 15.0m / 5m x 5m mesh)

- ◇ Volatile gas readings with portable photoionization detector (PID) every 20 cm along the lithological profile

- ◇ **85 soil samples**

- ◇ **25 undisturbed soil samples**

Granulometry, macroporosity, microporosity, fraction of organic carbon (foc) and vertical hydraulic conductivity

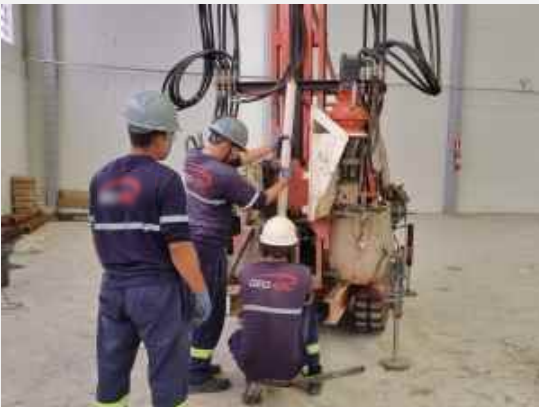
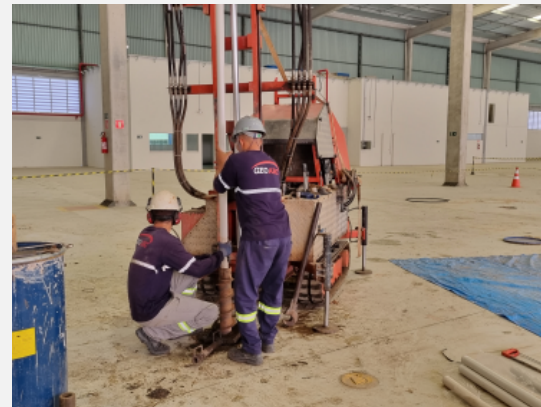
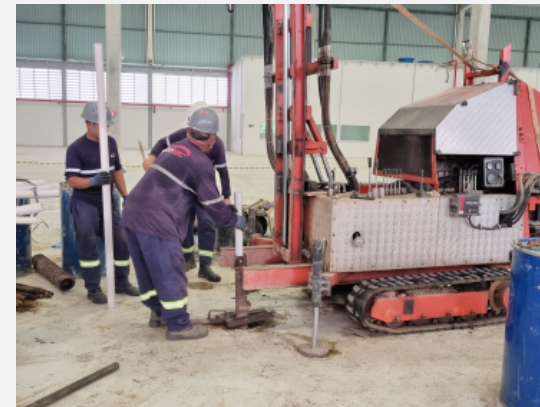
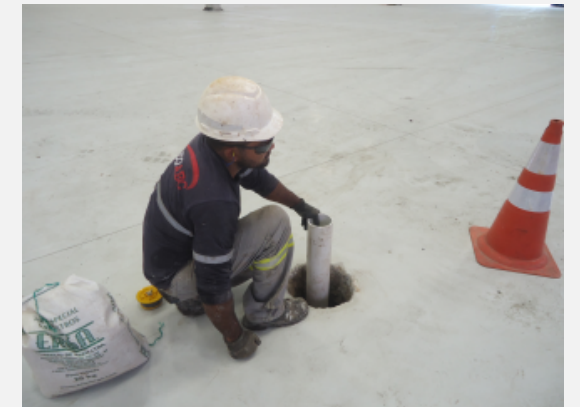
- Installation of **07 groundwater monitoring wells**:
  - ◇ 03 monitoring wells at the shallow level of the aquifer;
  - ◇ 02 monitoring wells at the intermediate level of the aquifer (level B);
  - ◇ 02 monitoring wells at the deep level of the aquifer (level C).
- Collection of **02 discrete groundwater samples** (grab samples).

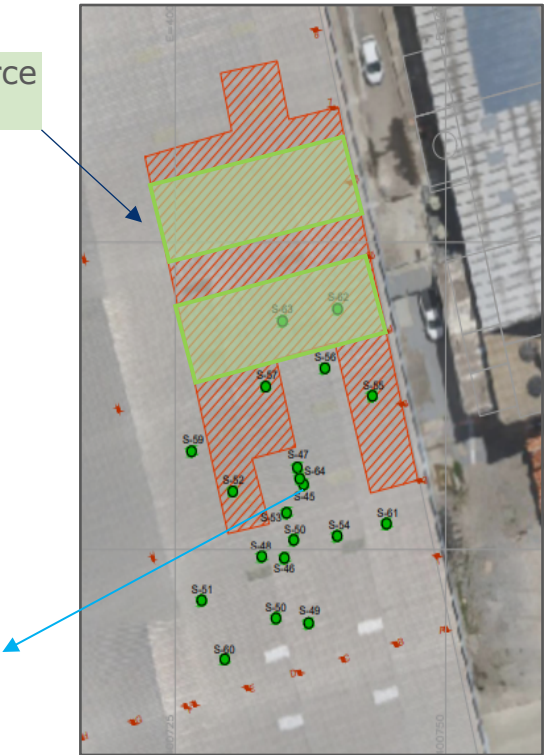
## S-45 Soil Profile

Sondagem: S-45 / Poço de monitoramento: PM-14C

- Regions characterized by areas of low permeability
- Most of the contaminant mass is in the **retained, adsorbed or residual phase**
- Correlation between the analytical results and the geotechnical results of the undisturbed samples:
  - granulometry/lithological profile, vertical hydraulic conductivity, fraction of organic carbon (foc) and effective porosity;
  - **predominantly clayey** soil, ranging from silty clay to organic clay, with **vertical hydraulic conductivity** between  $10^{-6}$  and  $10^{-5}$  cm/s, effective porosity between 1.9% and 2.9% and foc between 2.32% and 9.98%;
  - **04 main identified retention zones** are located at soil borings S-45 (5.9 m e 8.7 m), S-52 (4.9 m), S-53 (4.7 m e 5.5 m) and S-62 (4.5 m).

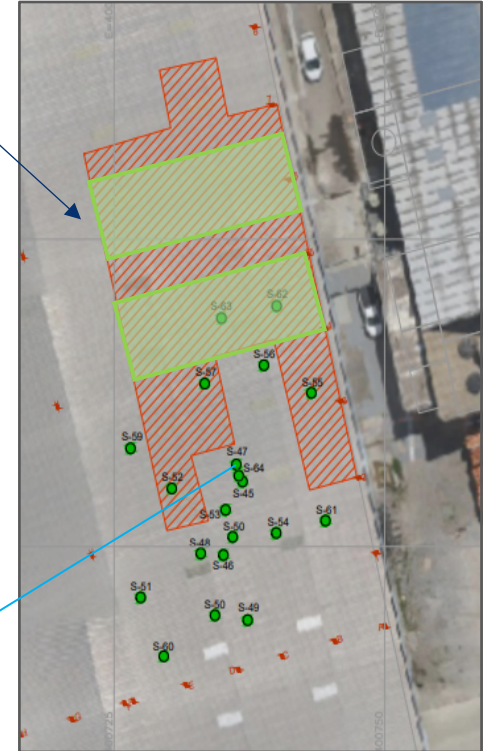
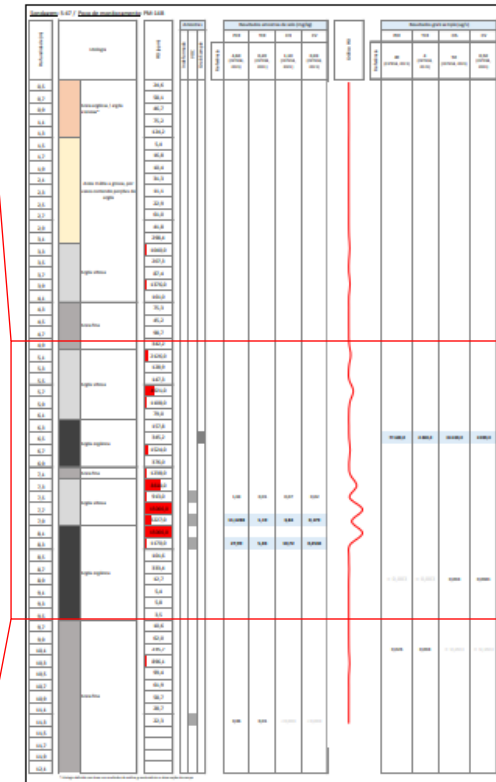
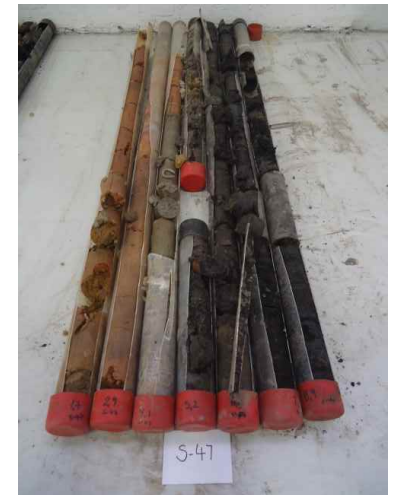
## S-47 Soil Profile

Sondagem: S-47 / Poço de monitoramento: PM-148

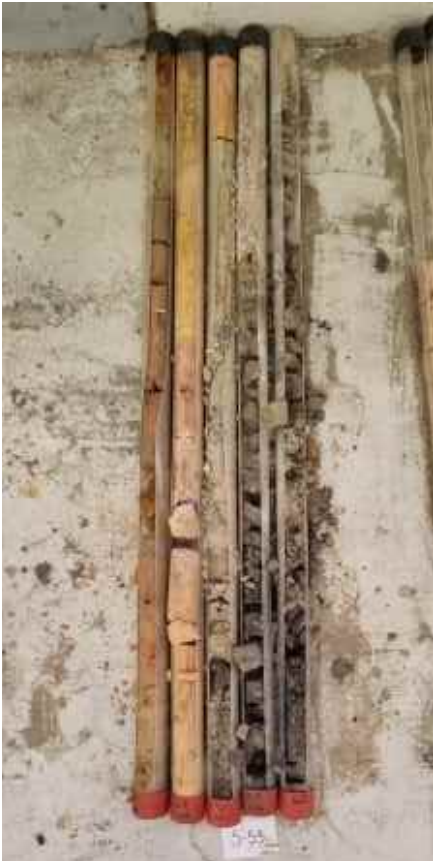
## S-53 Soil Profile

Sondagem: S-53
