# DPT Jet Injection for Enhanced Treatment of Chloropicrin in Low-Permeability Soils: A Five-Year Review

Chapman Ross, P.E. – FRx, Inc. – [cross@frx-inc.com](mailto:cross@frx-inc.com)

# Case Study: Northeastern US

# Case Study – Former Chemical Plant in Northeastern US

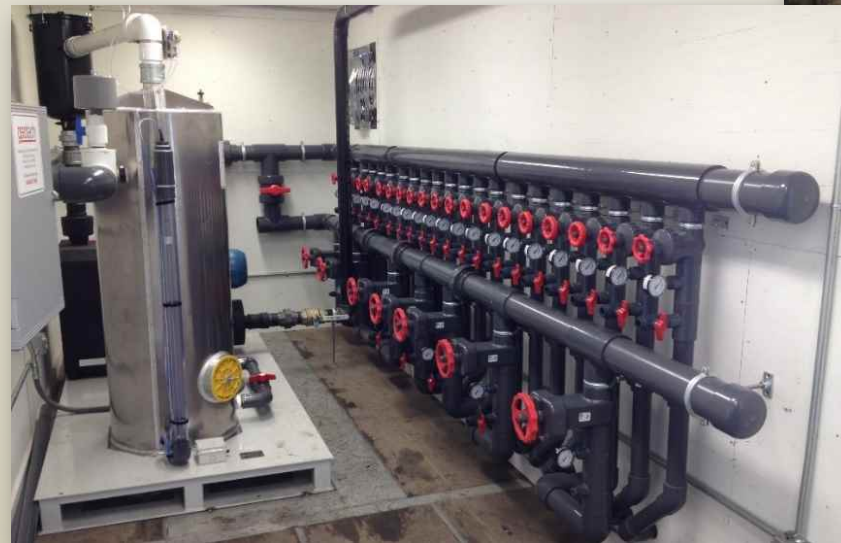
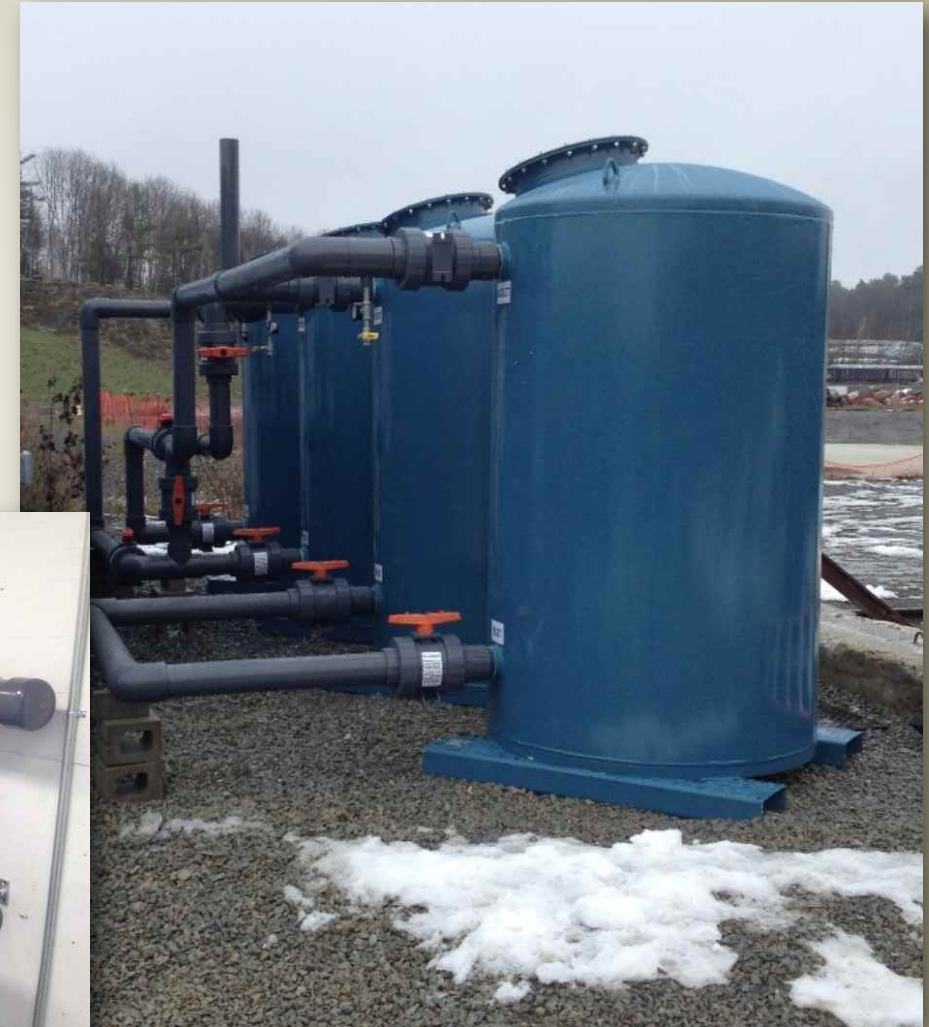
Full scale SVE system

- 20 shallow fracture enhanced SVE wells targeting clay and silt stratum
- 7 deep traditional SVE wells in sand and gravel stratum
