Rapid Abiotic Dechlorination of Chlorinated Solvents by Remediation Emplacement of Zero Valent Iron (ZVI)

PROJECT NO.: 2336-001C

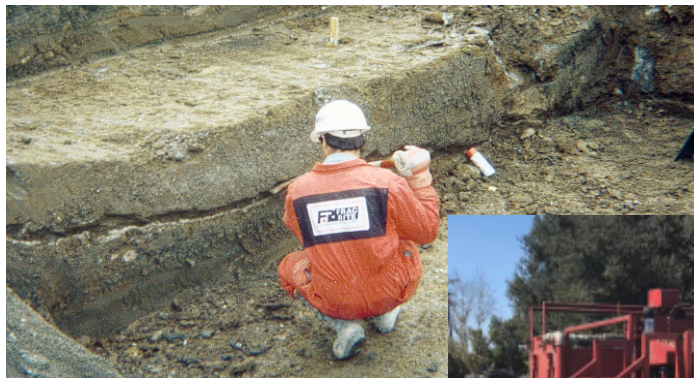
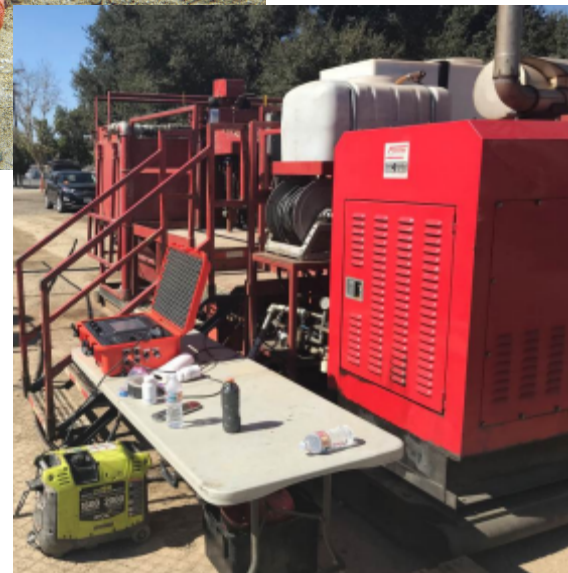
- Fracture- pressure induced tensile parting
- ZVI emplacement
- EF 9300 skid mounted mixing and pumping unit

- Time
 - 6 days
- Emplaced
 - 68,418 lbs of ZVI by fracture injection
- 27 Emplacement Boreholes (EB)
 - 110 discrete emplacement intervals (EI)
 - Create overlap and interconnectivity for GW plume treatment
- ZVI emplacement
 - EF 9300 injection unit (see first slide)
 - Slurry system
