# Investigation of a CVOC Plume in Multiple Fractured Bedrock Horizons and Remediation using a Combined Remedies Approach

Bruce Smith – Civil & Environmental Consultants, Inc.

June 6, 2024

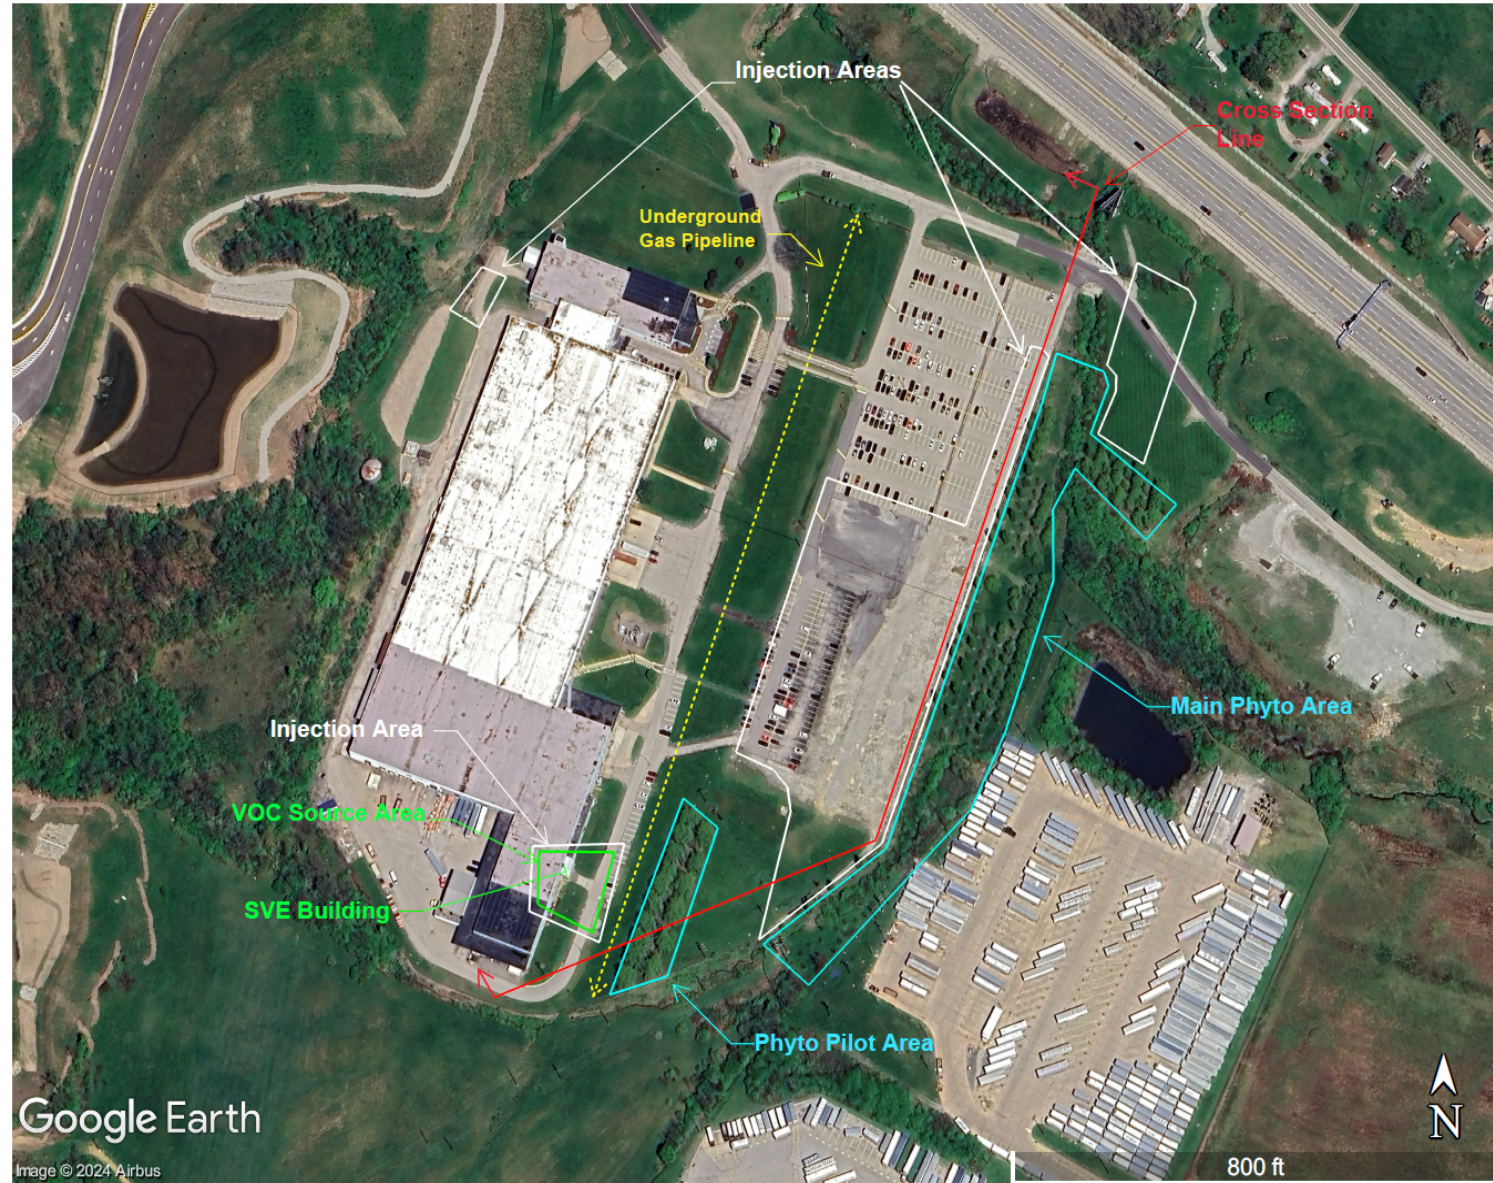
# Background and Site Layout

- Western Pennsylvania
- CVOCs in soil and groundwater

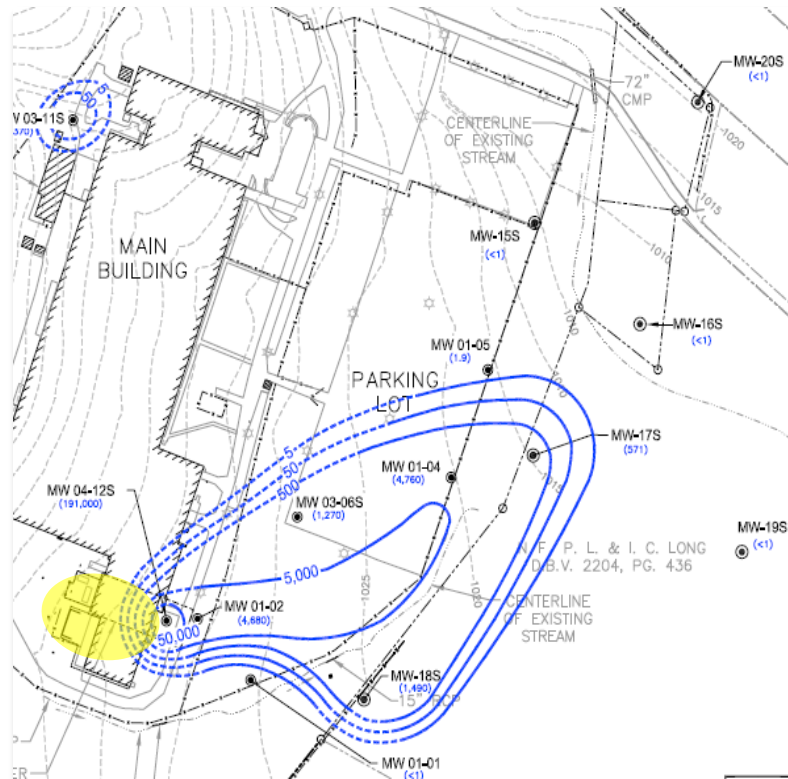
## Marine Shale

# Pre-Remedial Baseline Plumes

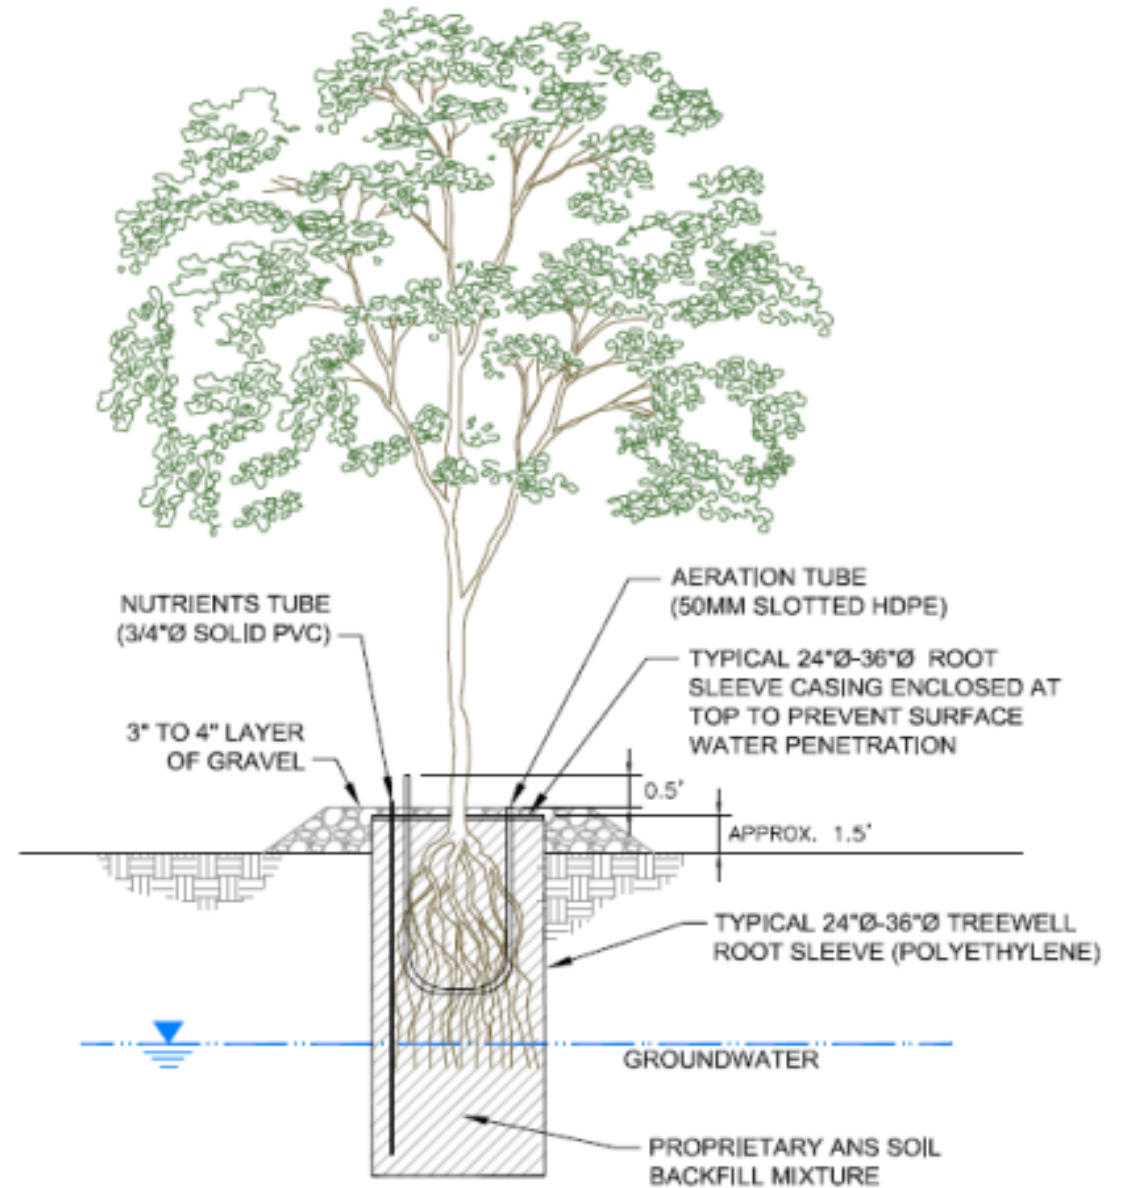
# Remediation

- SVE/SSDS
- Soil Removal
- TreeWell® Technology
- ERD

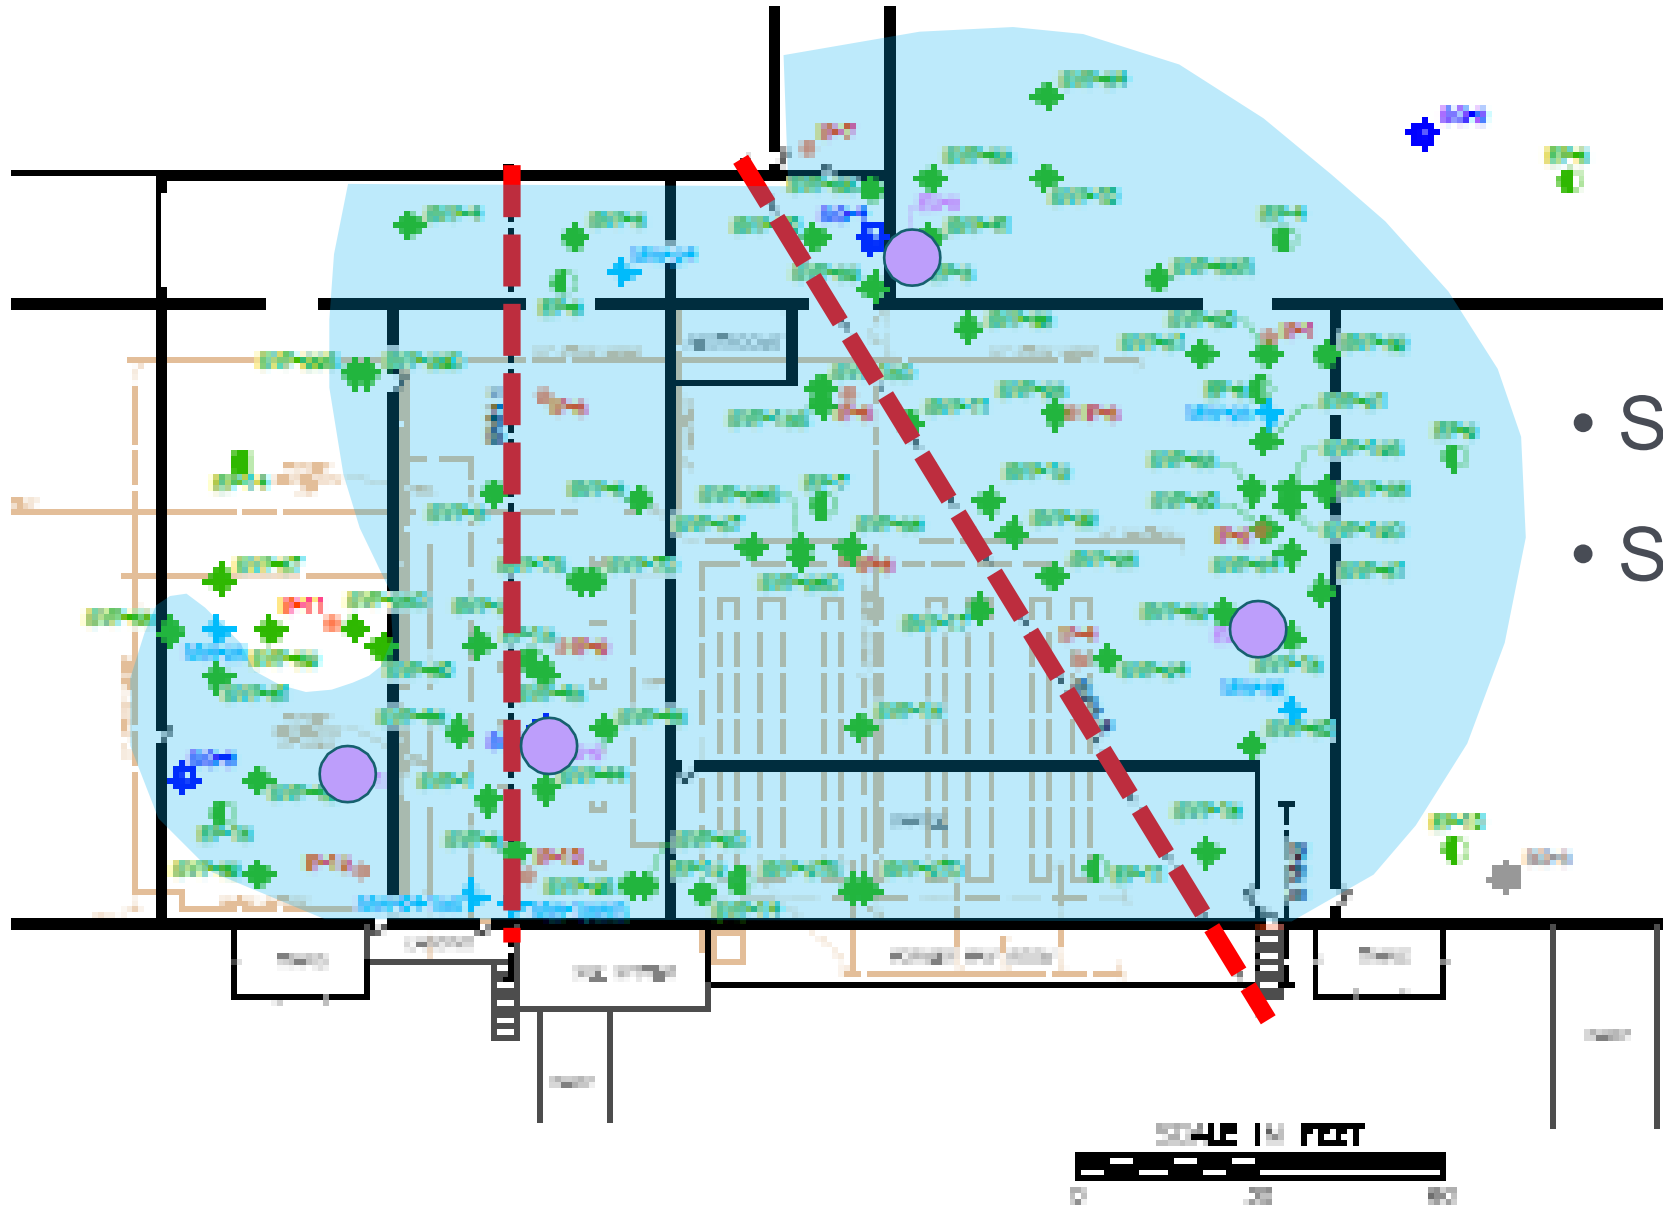
# SVE/SSDS

- SVE - 2 horizontal wells
- SSDS – 4 vertical wells

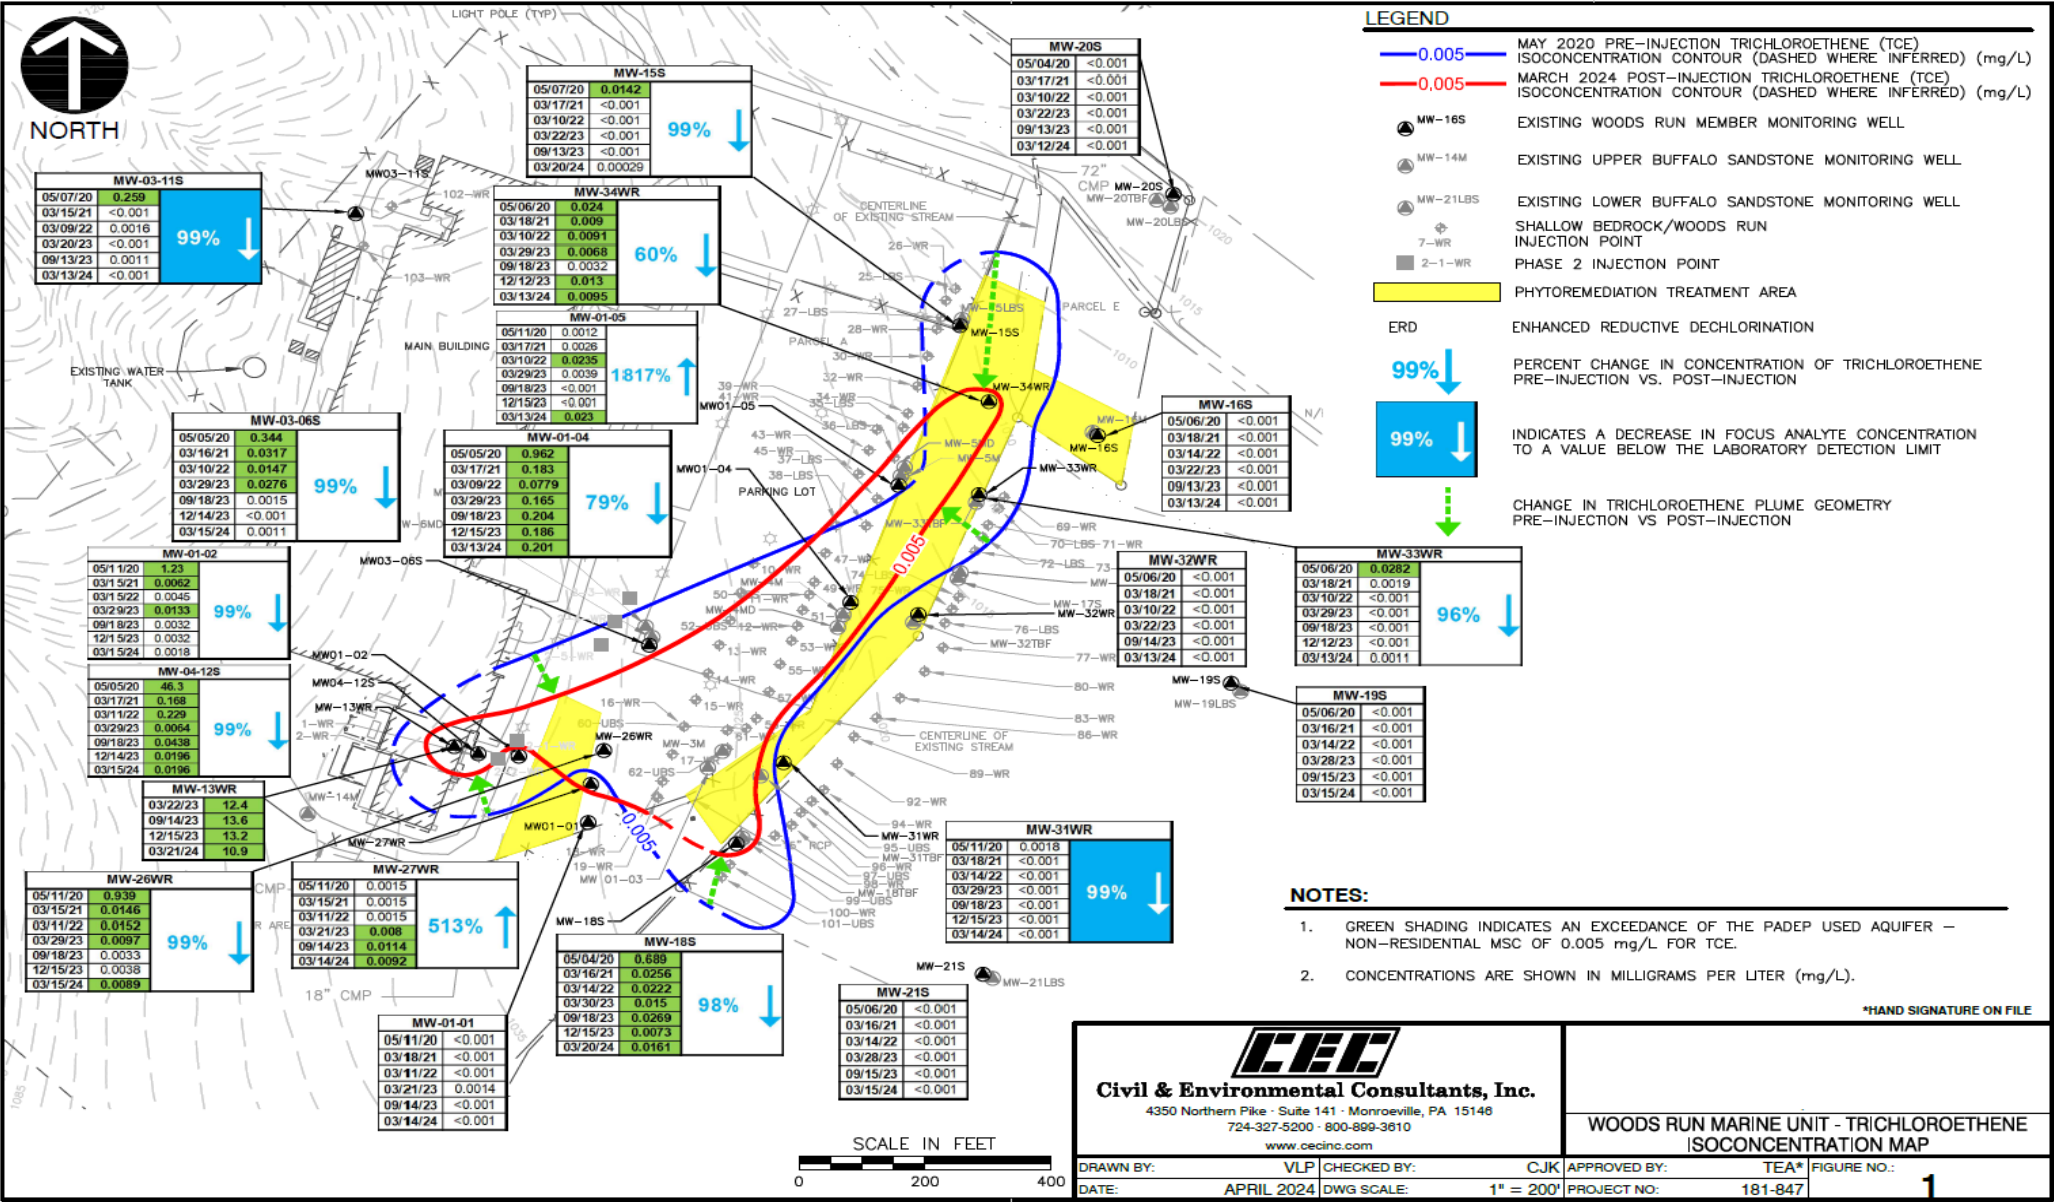
# Marine Shale Pre/Post ERD Plumes

- Amendments
  - 3DMe®
  - SDC-9™/BDI Plus
  - CRS®
- Application
  - Soil/Bedrock Interface -11 Initial Points/4 Second Phase
  - Marine Shale – 45 Initial Points/21 Second Phase
  - Upper Sandstone – 30 Initial Points/14 Second Phase
  - Lower Sandstone – 27 Initial Points/11 Second Phase
