# Thermal Remediation in the Vicinity of Dense Utility Installation

*The HECO Site  
Dyersburg, Tennessee*

Phillip Coop, CHMM – EnSafe, Project Manager  
Steven Hodskins, PE – EnSafe, Project Engineer  
Susan Avritt, PE, PG – TRS, Project Engineer  
Mark Boulos – TRS, Project Engineer

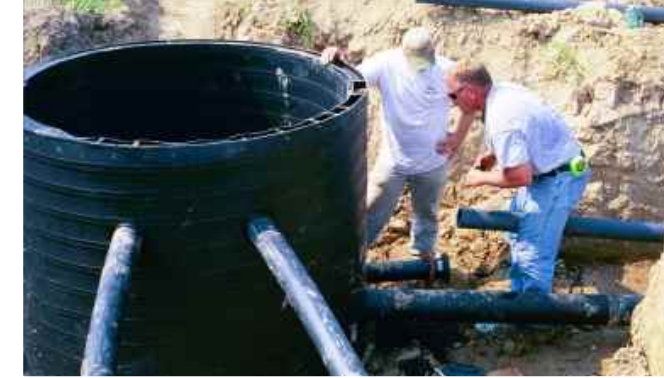
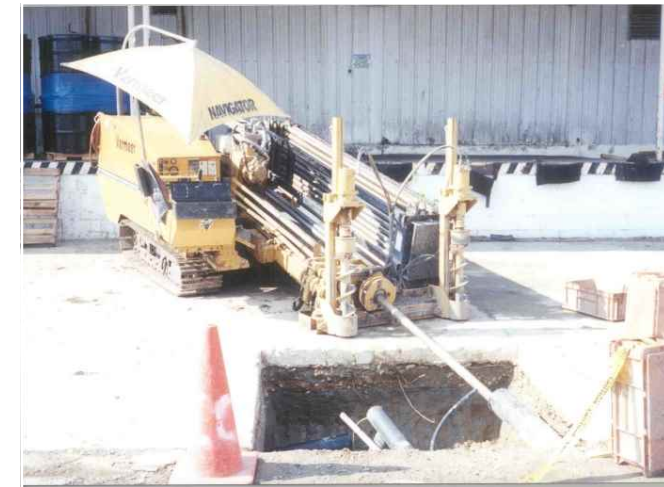
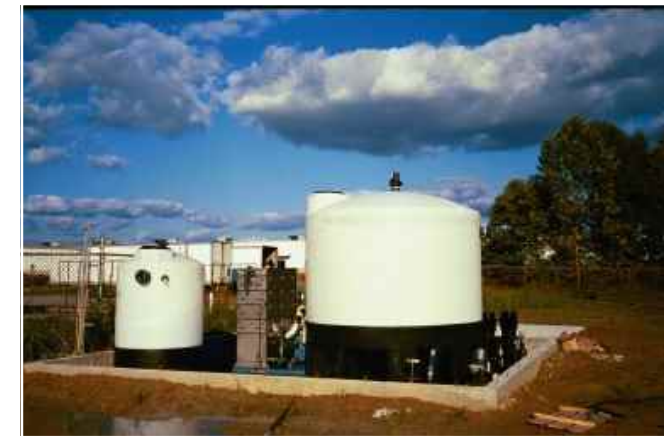
# Site History

| 1995 - 2002 | ● Environmental investigations resulted in the construction of a dual-phase extraction (DPE) system of four horizontal extraction wells and one vertical well beneath and downgradient of Building 2 to address TCE contamination and protect fluvial groundwater by interrupting the migration pathway from saturated overburden soils. |
| 2003 - 2004 | ● Carbon amendment injection system consisting of 3 fluvial injection wells was installed to enhance biodegradation of the fluvial contaminant plume. Recovery well PW-1 installed at southern border to provide source water for the injection wells. |

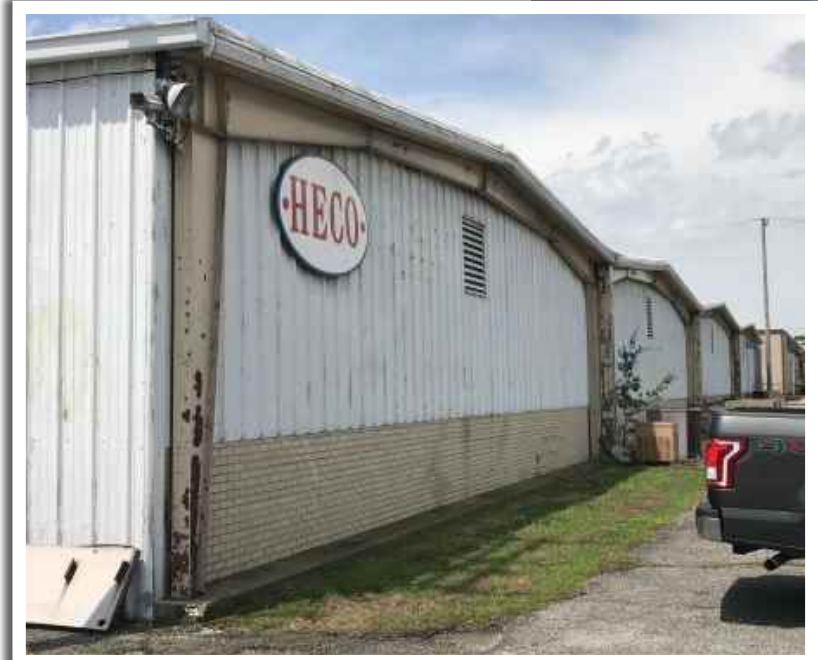
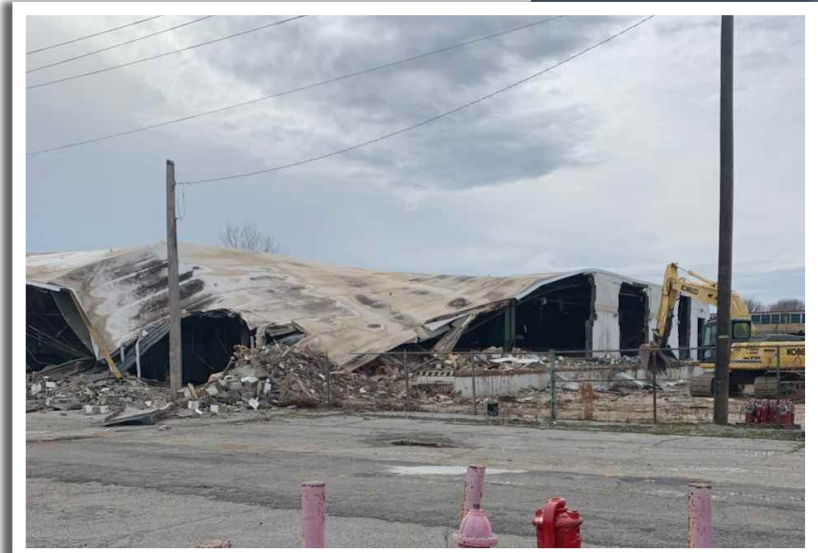
# Changed Land Use

- Building 1
  - No longer in use – sub-slab contamination.
  - Low overhead clearance and poor condition.
  - Vapor mitigation vs demolition and thermal treatment.
- Building 2
  - Minimal use as warehouse.
  - Highly contaminated soil mass = thermal treatment.
  - Demolition to facilitate thermal treatment system installation.
- Building 3
  - Available for new tenant/provide jobs for the community.
  - Vapor mitigation vs thermal treatment and monitoring.
- Area A
  - Highly contaminated soil mass = thermal treatment.
- Area B
  - Existing trees provide phytoremediation.
  - Land use controls and monitoring.

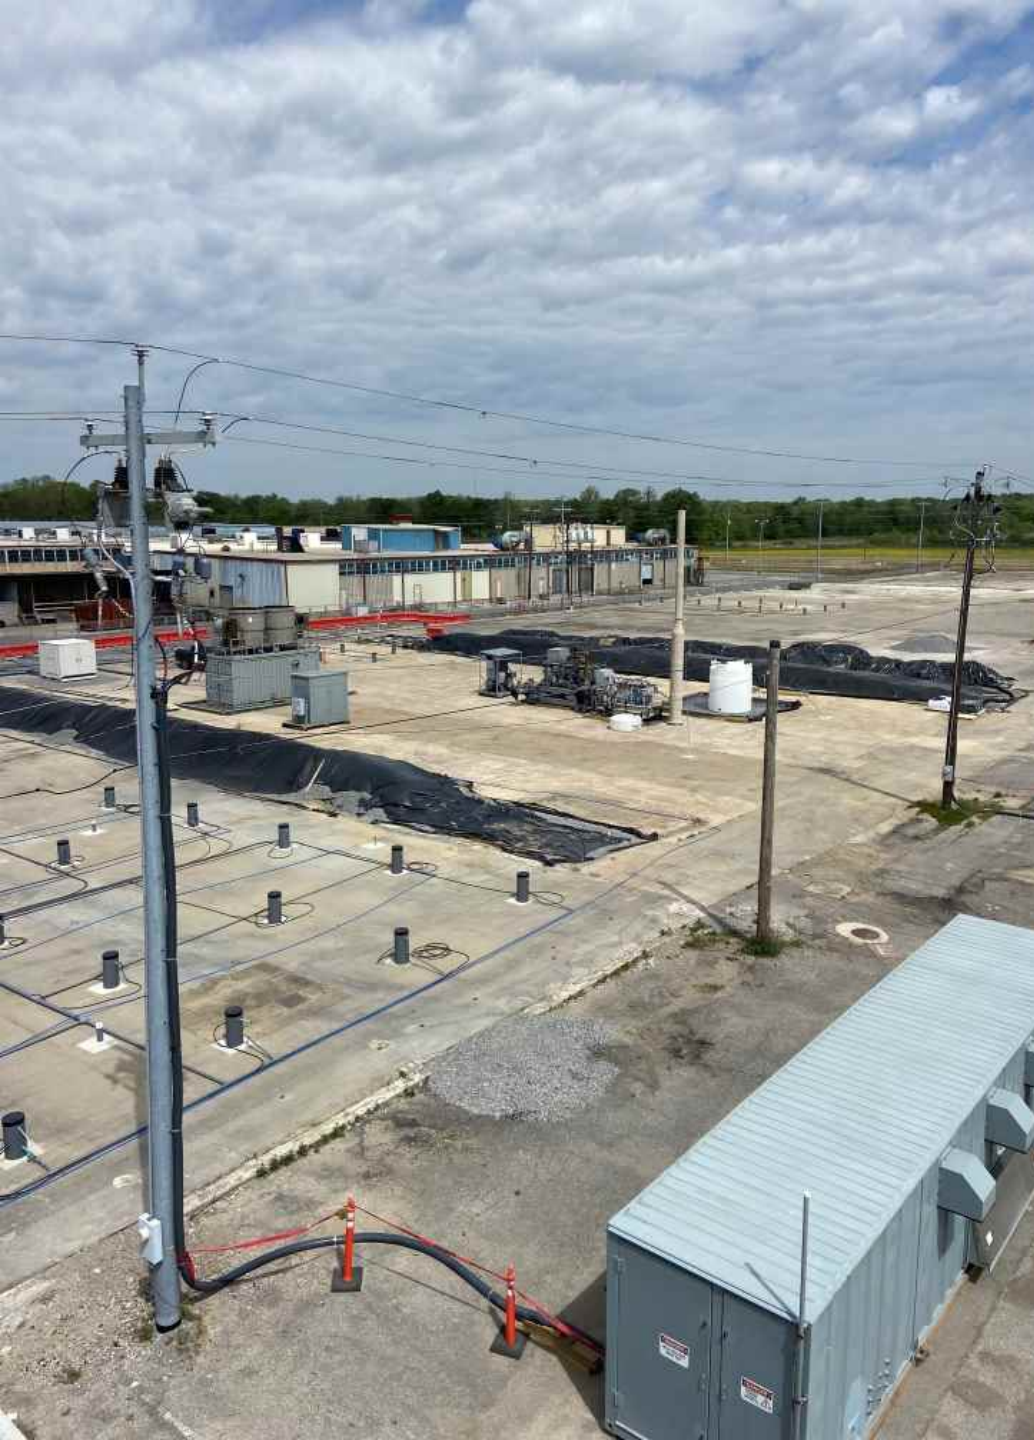
# Technical Approach

- Electrical resistance heating
- Regenerative thermal oxidizer vapor treatment
- Treatment partially under building
- Average thermal treatment depths
  - Shallow treatment extent: 2 ft bgs
  - Deep treatment extent: 35 ft bgs
