# In Situ Thermal Treatment of DNAPL Site Using Sheet Pile Electrodes

Former Wastewater Treatment Facility Site  
Salem, New Hampshire, USA

# Former Wastewater Treatment Facility

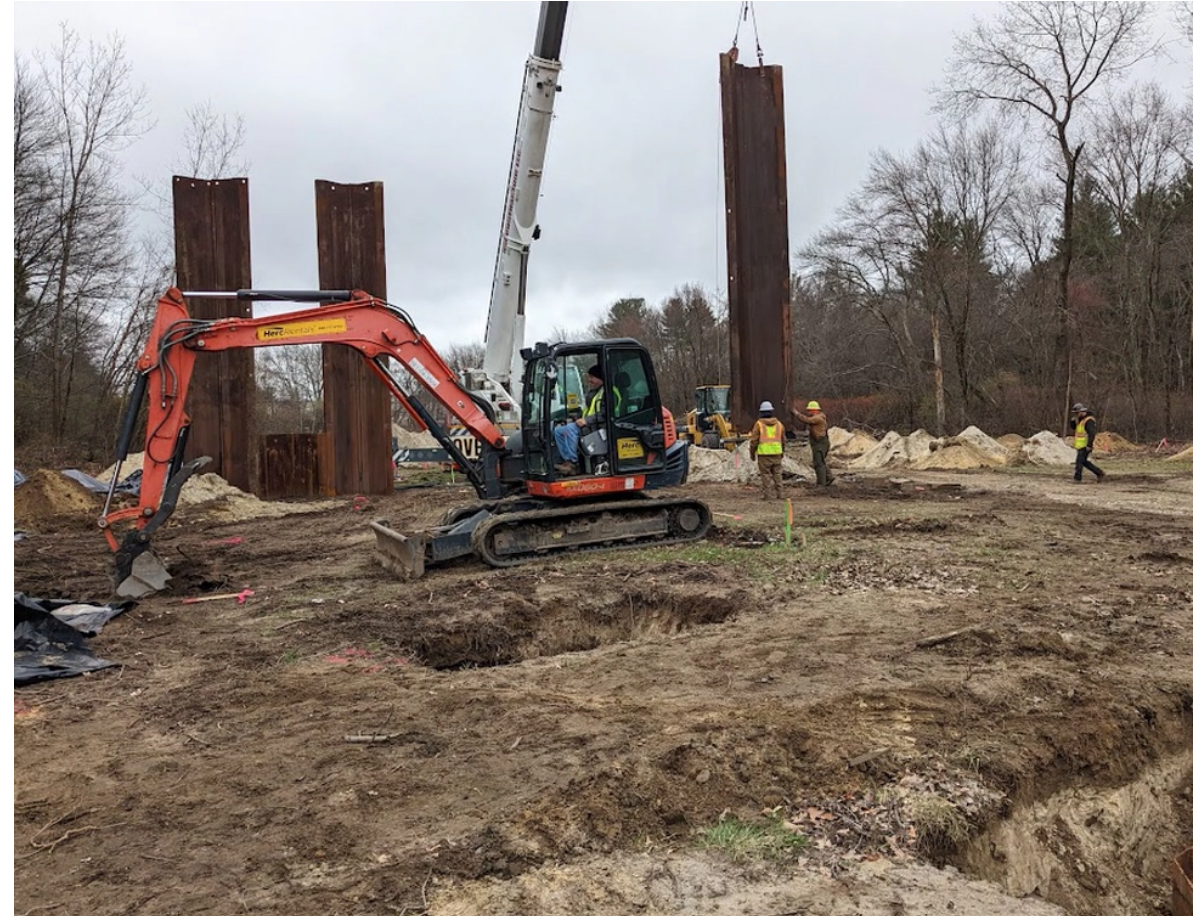
# Sheet Pile Electrodes

- ▶ Site suitability evaluation required
- ▶ Reduced installation time
- ▶ Recyclable materials
- ▶ Minimized contaminated soil cuttings
- ▶ Reduced management, transport, secondary liability

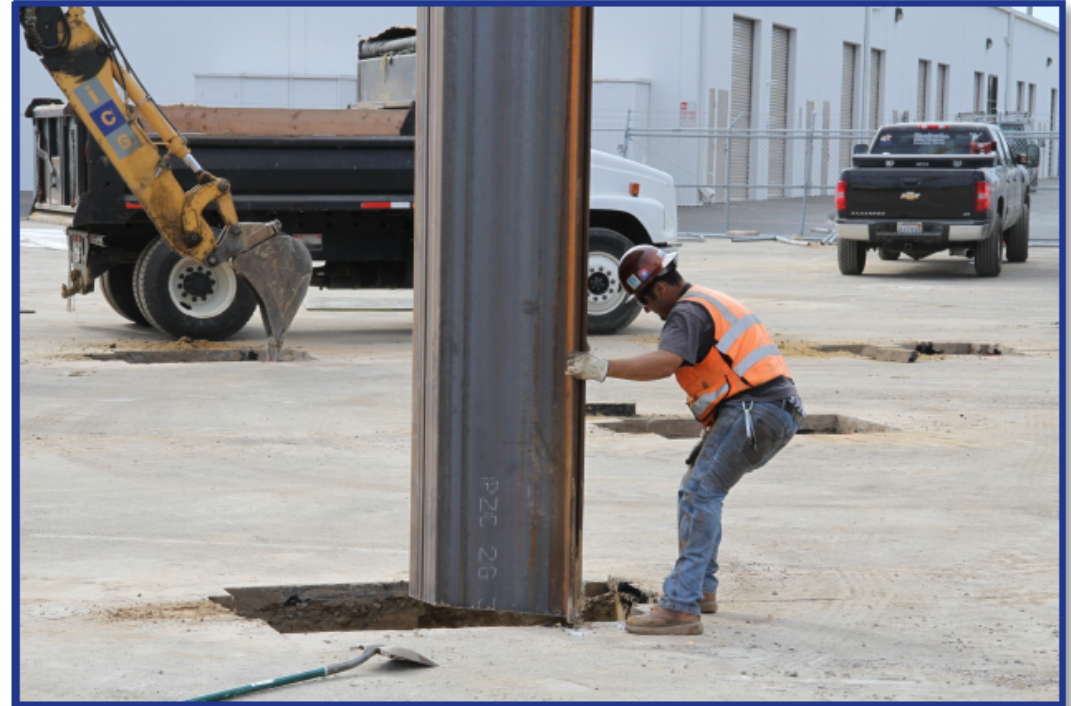
# Sheet Pile vs Bored Electrodes

- ▶ 161 sheet pile electrodes
  - ~30 minutes per electrode
  - 81 hours sheet pile driving
- ▶ 185 bored electrodes equivalent power
  - 384 hours drilling estimated
- ▶ 166 tons soil cuttings eliminated

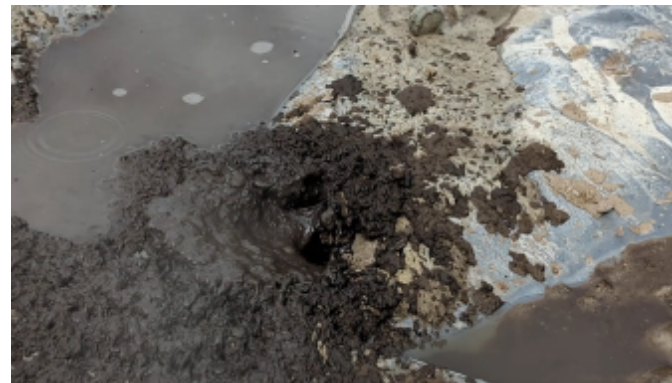
# Soil ERH Performance Assessment

- ▶ 40 samples from 26 boring locations
  - DNAPL and NH SRS areas
  - Co-located with previous data
- ▶ August 30 - DNAPL milestone
  - 3 samples: TCE > 10% sol. (DNAPL)
  - 11 samples: TCE and/or c-DCE > SRS
- ▶ October 5 - NH SRS milestone
  - DNAPL not present
  - 3 samples: TCE and/or c-DCE > SRS
  - Remediation goal achieved based upon 95% UCLs below NH SRSs
