# Overcoming Implementability Challenges: Activated Carbon Slurry PRB Installation to Prevent LNAPL Migration to Surface Water Body

Chad Smith ([Chad.Smith@pbfenergy.com](mailto:Chad.Smith@pbfenergy.com)) PBF Energy, Inc.

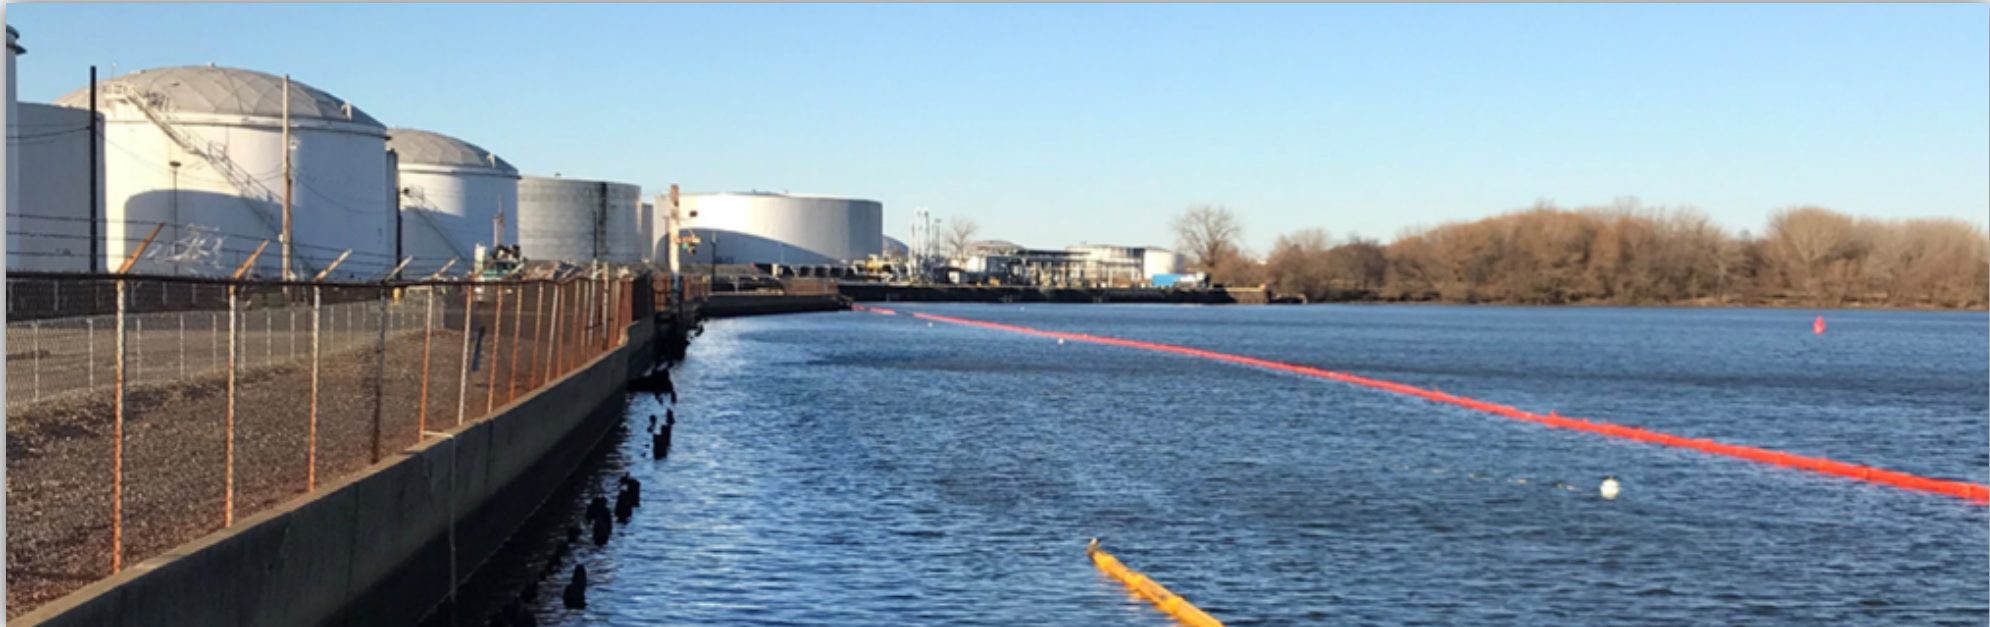
# Site Background

- Active petroleum product storage and distribution facility located along a surface water body
- Light non-aqueous phase liquid (LNAPL) observed seeping beneath a bulkhead (seawall) at low tides
- LNAPL source was mitigated, and recovery efforts focused on removing LNAPL accumulating behind the seawall
- Occasional LNAPL seeping continued at low tides
