# INSTALLATION OF A SUCCESSFUL ACTIVATED CARBON BASED PERMEABLE REACTIVE BARRIER FOR PETROLEUM HYDROCARBONS AND 1,2-DCA

Mike Mazzaresse  
Senior Remediation Engineer  
Denver, CO

**2024 Chlorinated  
Conference**

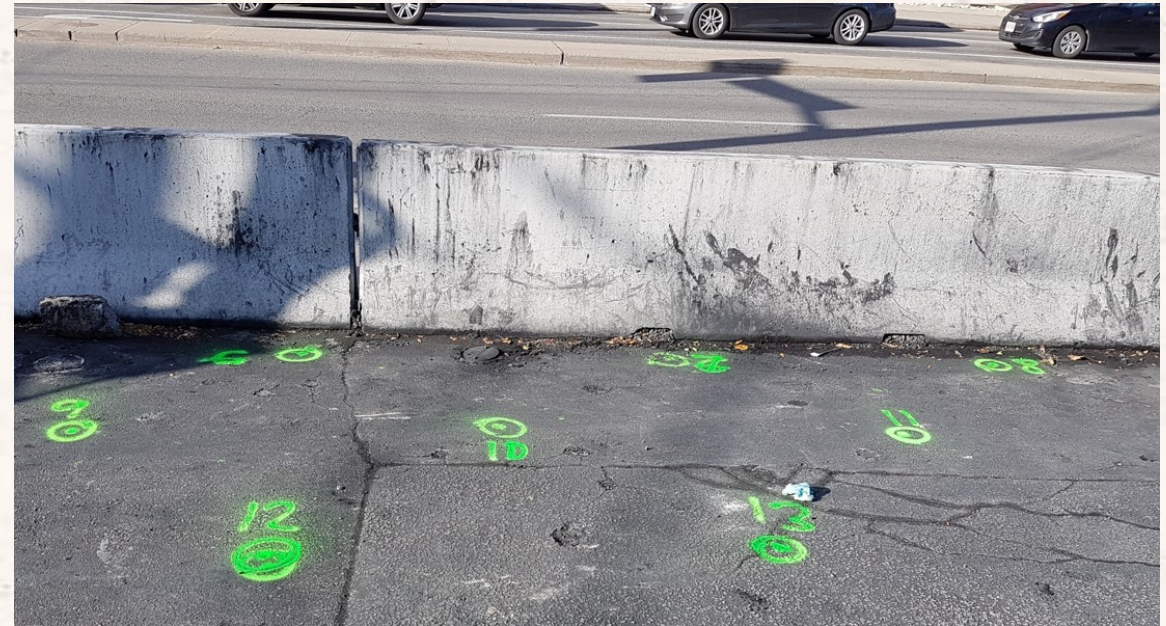
Phase 4 preceded by Remedial Design Characterization (RDC) to better define plume and saturated soil mass

- Application of Powder Activated Carbon, terminal electron acceptors, and hydrocarbon degrading bacteria
- 81 injection locations with 9 discrete intervals

Phase 5 included the addition of a dechlorinating culture that is capable of degrading 1,2-DCA
