# Natural Attenuation of Toxins Released in the East Palestine, OH Train Derailment Accident

Rapid Response Research  
(RAPID) grant

Department of Civil & Environmental Engineering  
University of Tennessee Knoxville

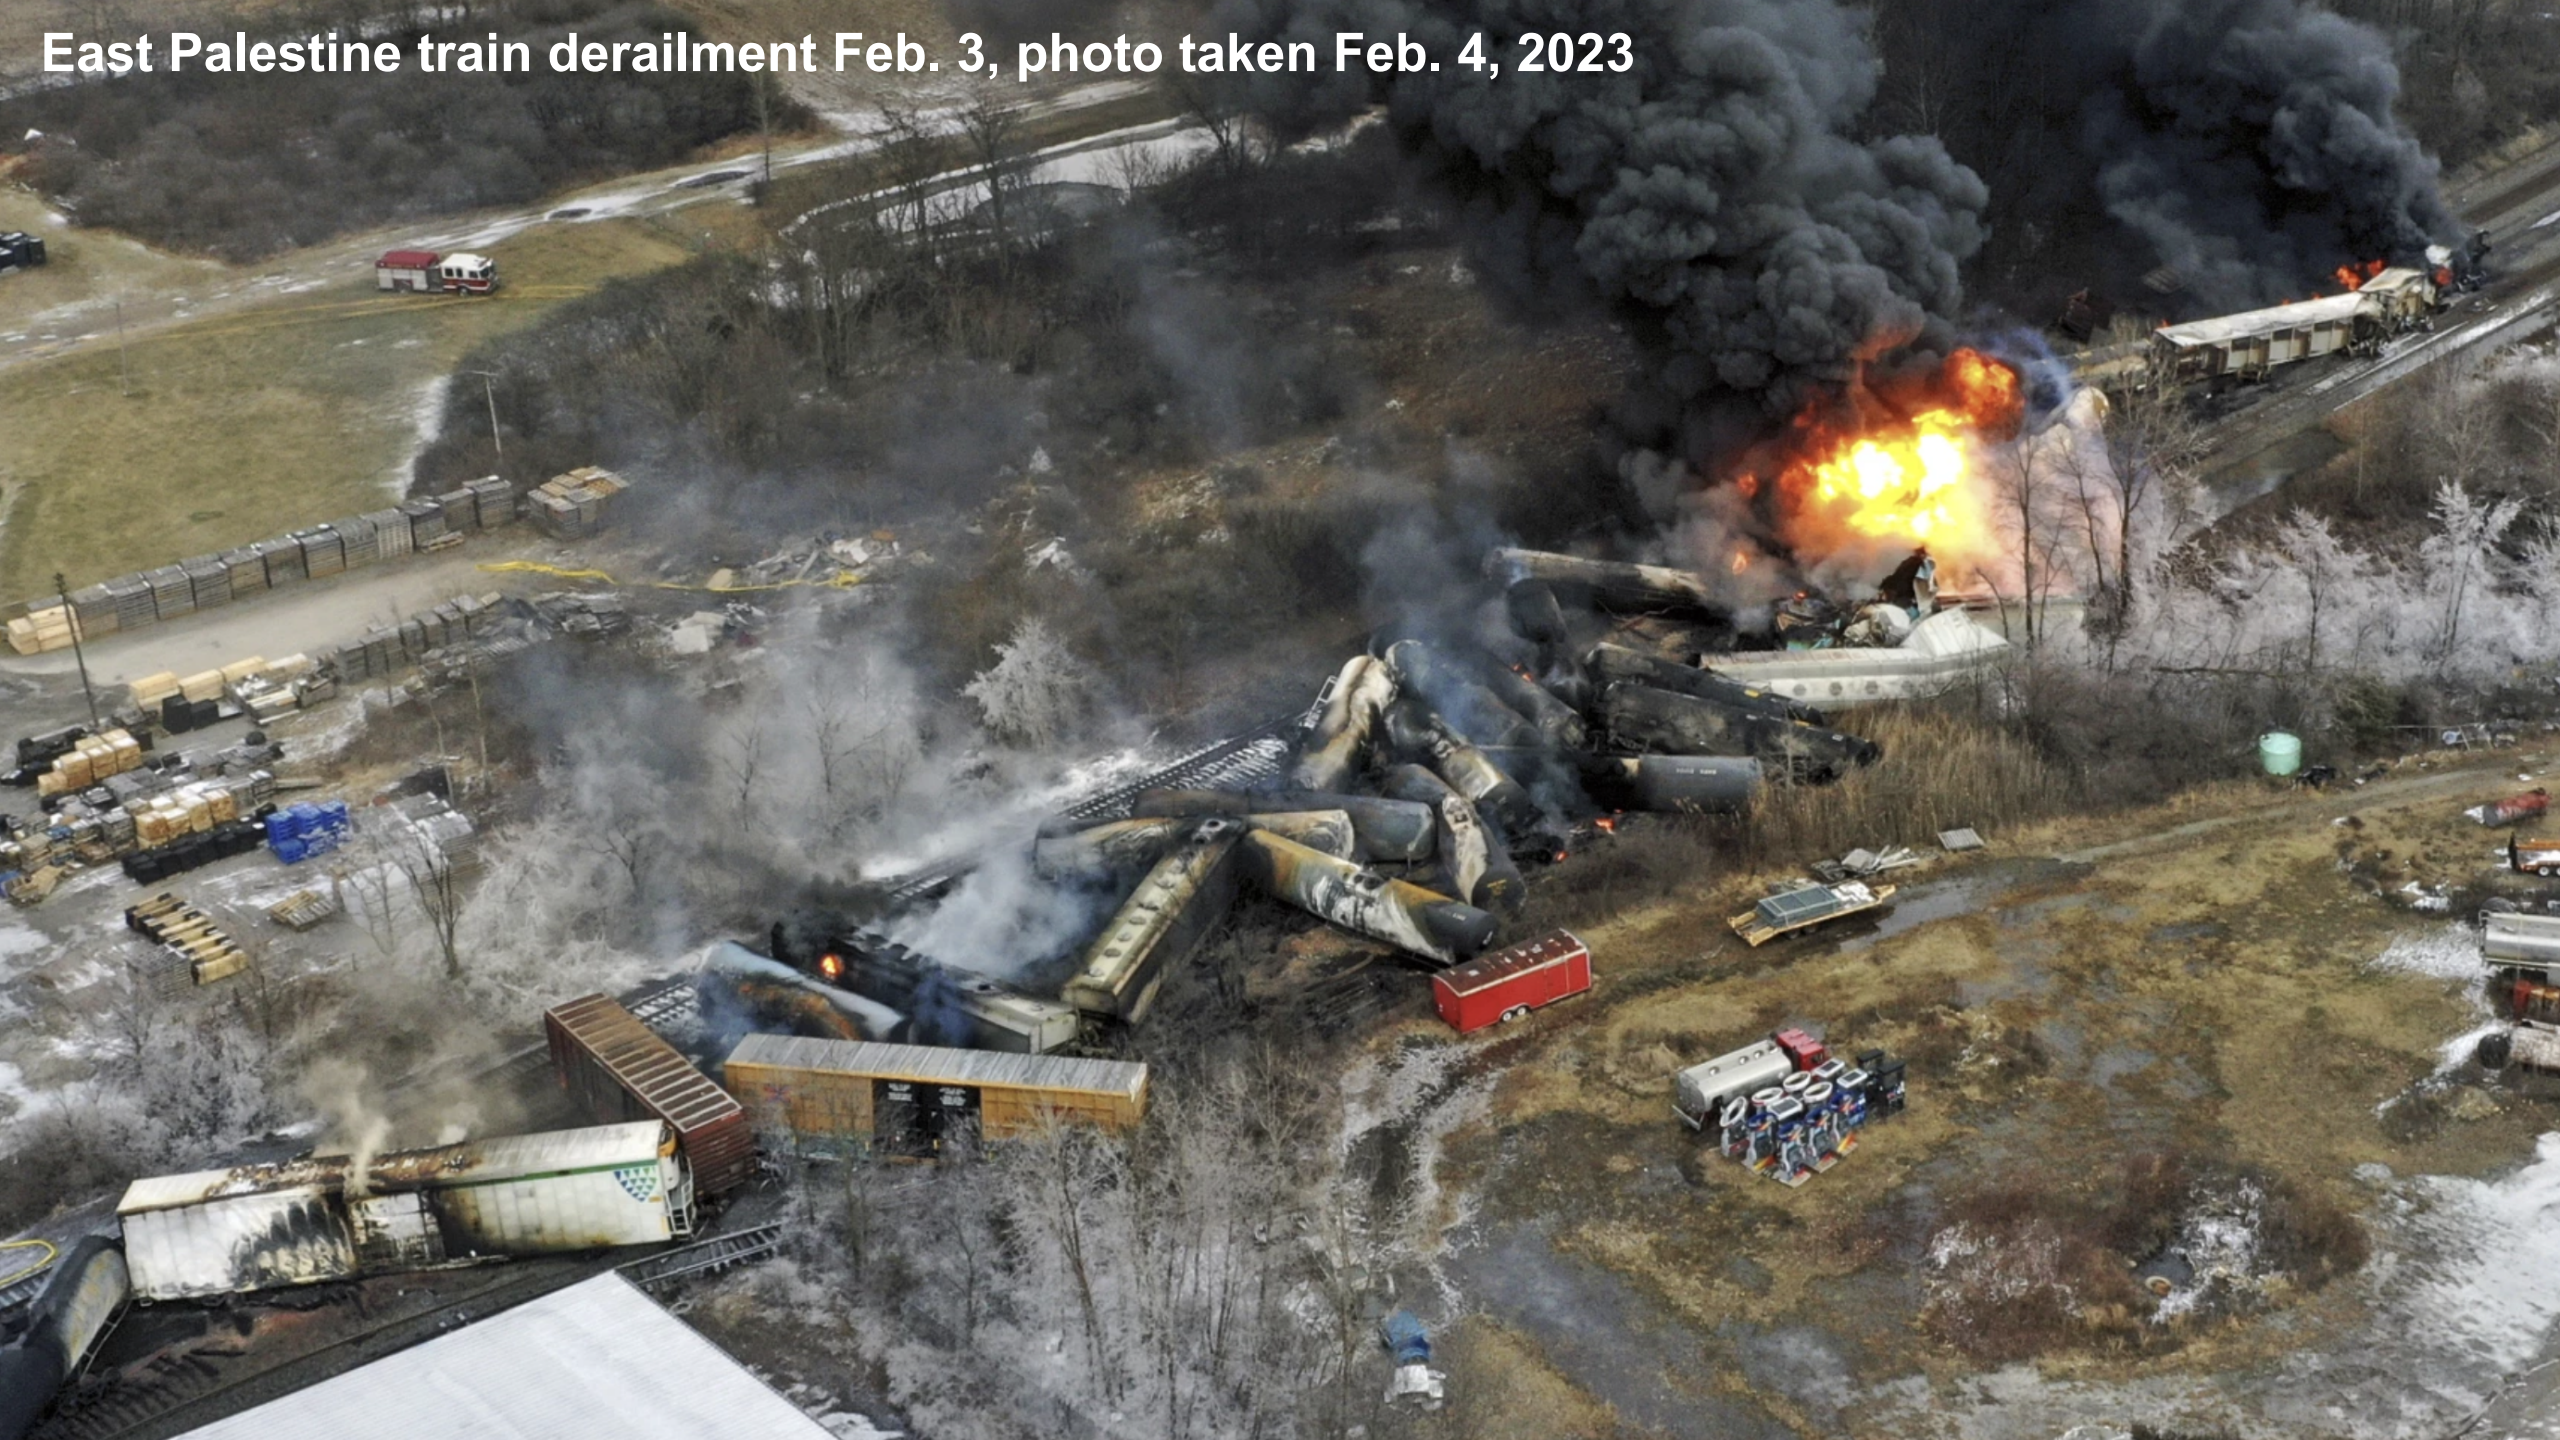
East Palestine train derailment Feb. 3, photo taken Feb. 4, 2023

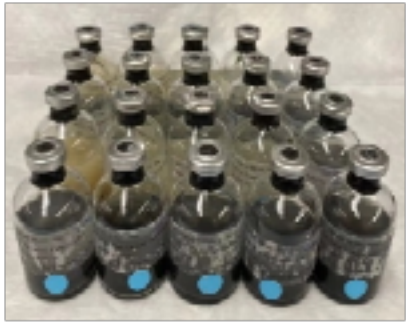
# VC Degradation in Oxic Microcosms

Aerobic VC degradation occurred in all sediment microcosms

Lag phase: 20 – 40 days
