# Horizontal Electrodes to Minimize Business Impacts – Installation Strategies and Implementation

Abstract #: 240 | Session: H9  
Chris Thomas

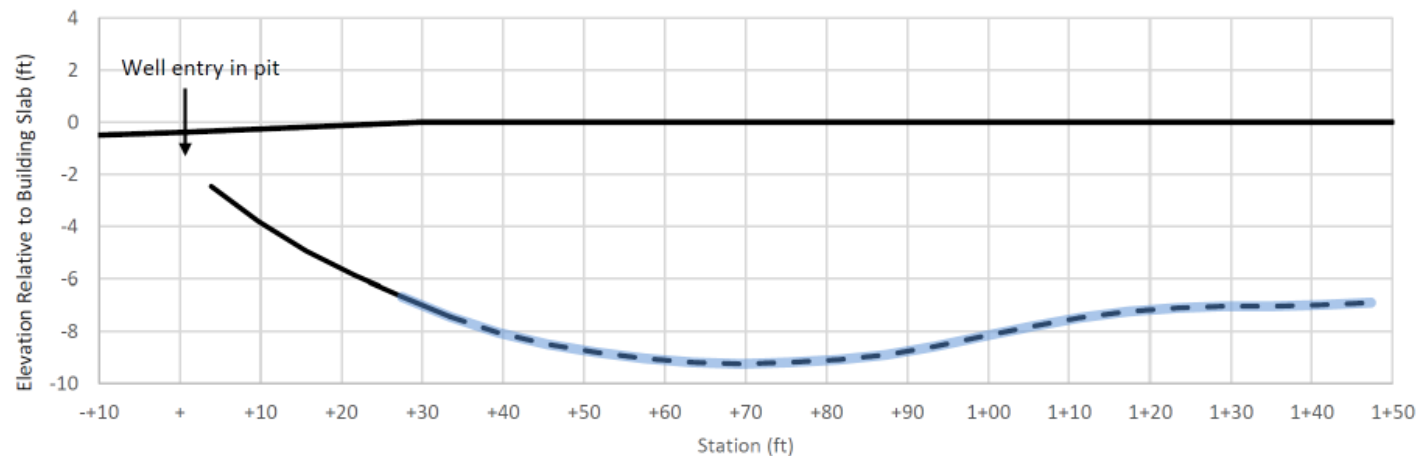
HD-06

# Direct Drilling Rig

Prepared by Ellingson-DTD

Vertical Exaggeration ~ 1.3x

Drilled Length: 175 ft  
Horizontal Length: 174 ft  
Well Length: 162.75 ft  
Well Casing: 31.5 ft 3.5 inch SCHD 40 steel riser  
Well Screen: 131.25 ft 3 inch SCHD 40 steel screen  
Date Completed: 7/9/20  
Conductive Backfill: 850 lbs topped with 35 gal neat cement grout

**Start of Screen**

Station: 00+31.5

Depth below entry: -7.7 ft

**End of Screen**

Station: 01+62.75

Depth below entry: -6.6 ft

(Note: Station 0+0 at Survey point for well start HD-03)
