# NOT ALL IS AS IT SEEMS

Reinvestigating A Persistent Benzene Plume Using HRSC

Emma Walsh, Graeme Miller, Michelle Agnew

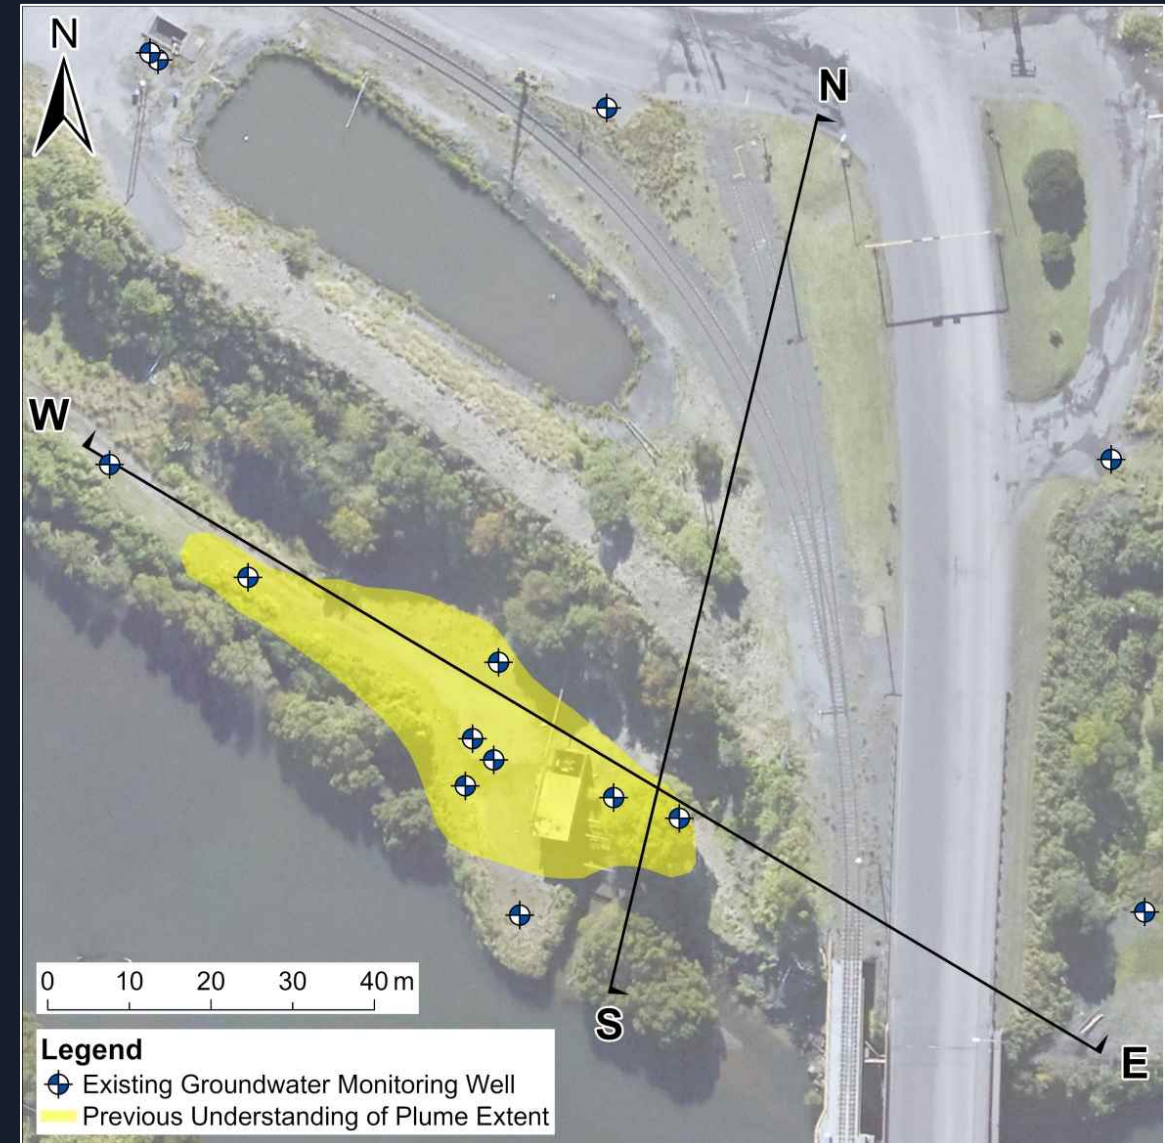
- Post remediation benzene concs remained up to 600 mg/L.

Senversa recommended revision of CSM prior to preparation of a RAP.

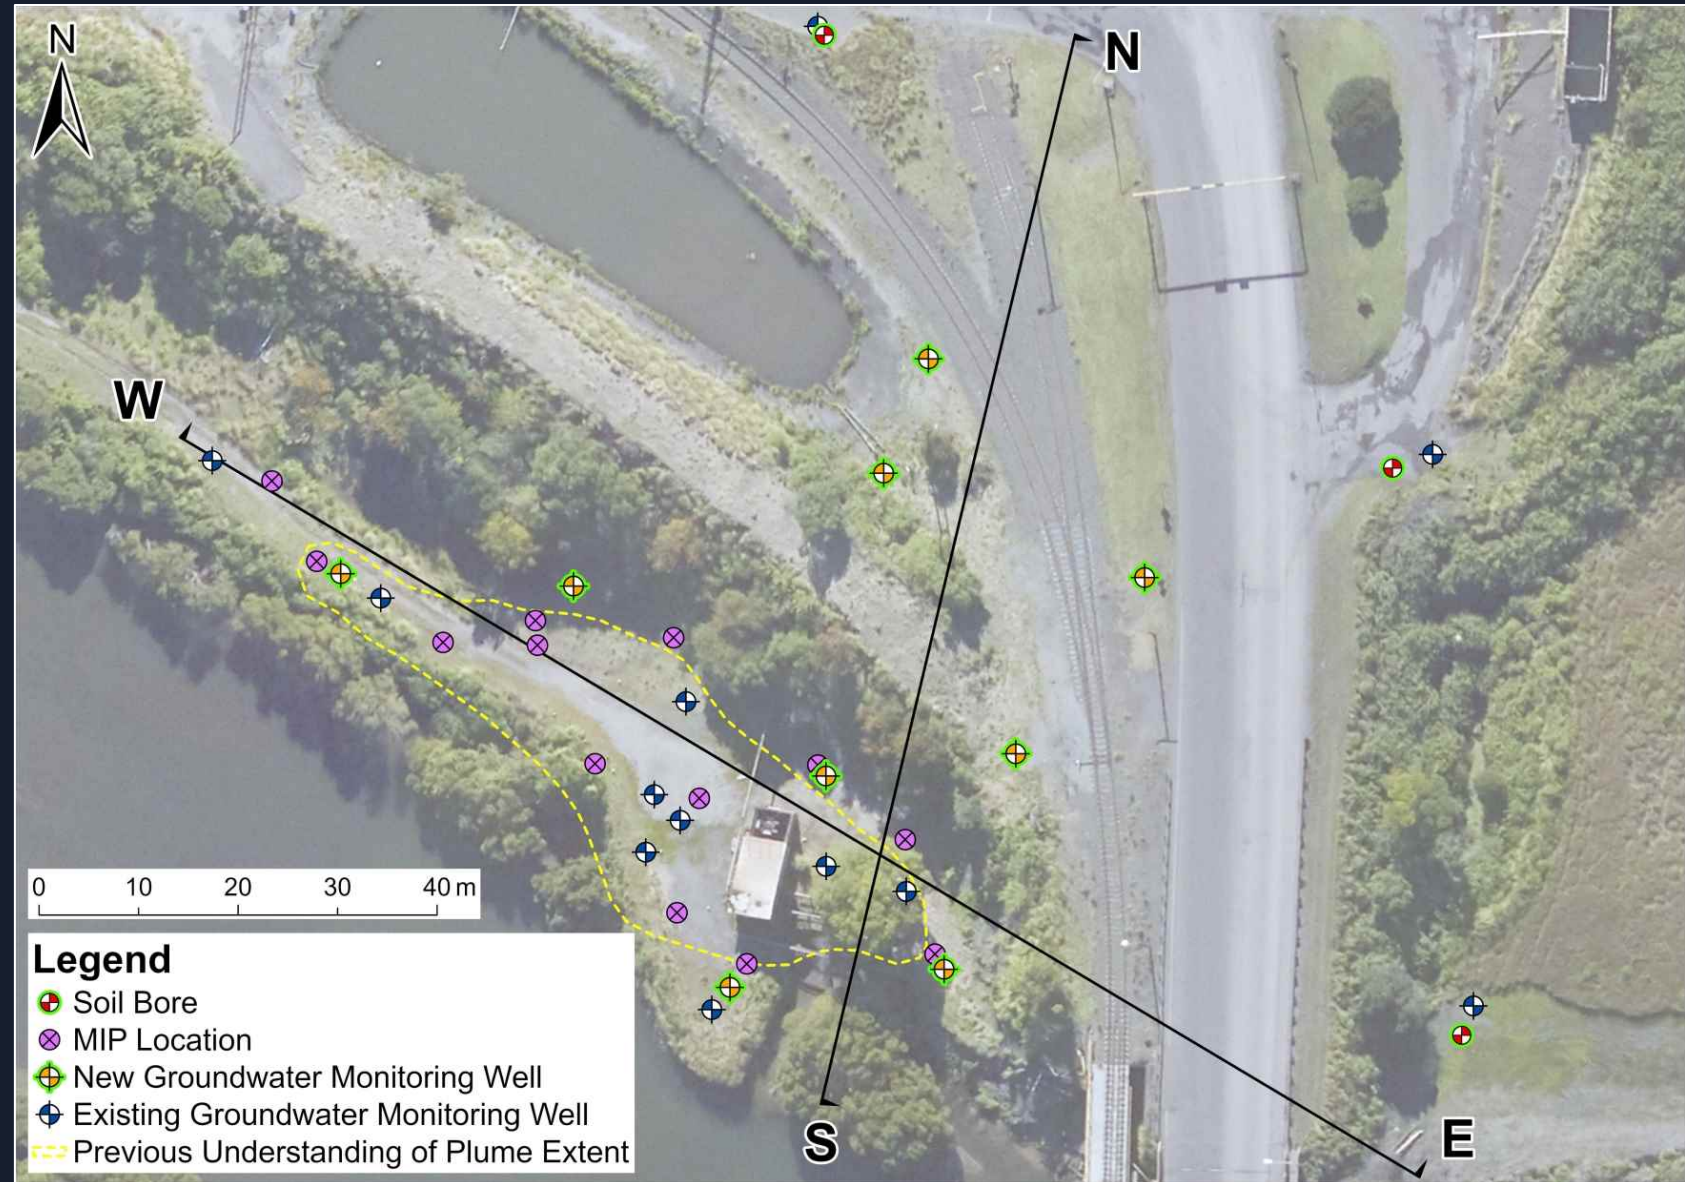
- Survey of MIP investigation points.
- Installation of new deeper monitoring wells along lower embankment.
- Installation of new monitoring wells to north and east.
- Confirmed MIP responses.
