# **Variability in Fill Material and an Abundance of Underground Utilities Complicates the CSM and Remedial Approach at a MGP Site on Lake Superior**

Heather Hallett, PG, CPG; Brian Symons, PE;  
Michael S. Raimonde

A presentation to:  
Battelle Chlorinated Conference

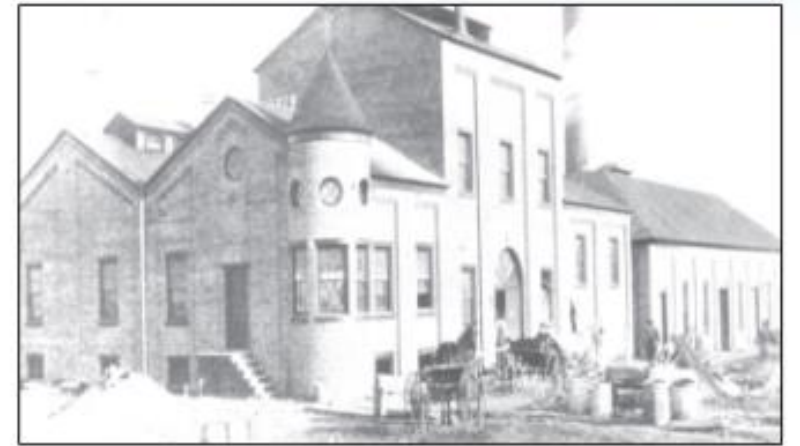
Manufactured gas plant in Superior, Wisconsin, ca. 1889.

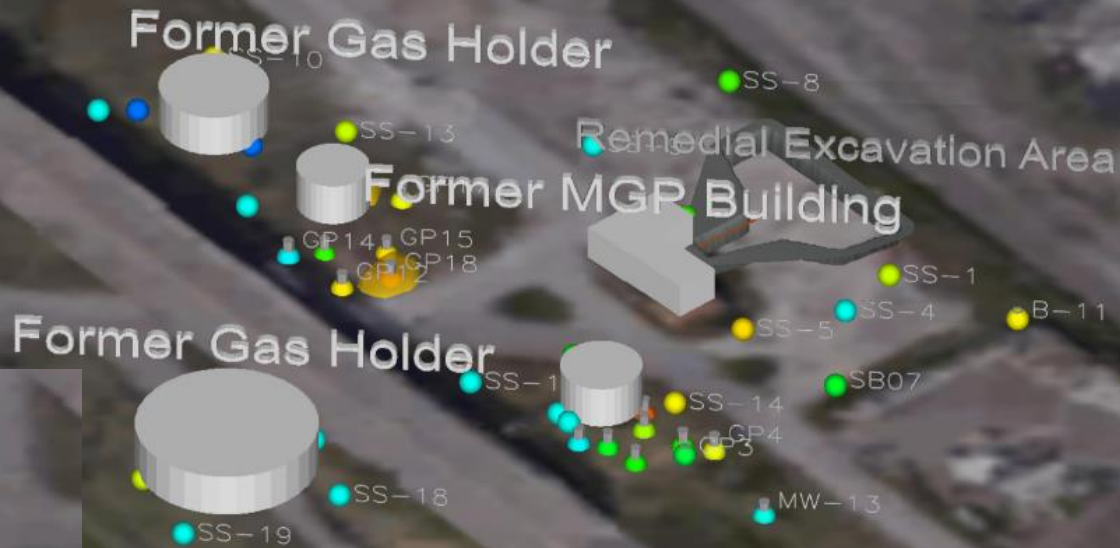
# RI Results – Benzene in Shallow Soil

Soil Benzene Samples in Top 4 Ft.  
and Impacts > 7.07 mg/Kg  
(Industrial Direct Contact Residual Contaminant Level)

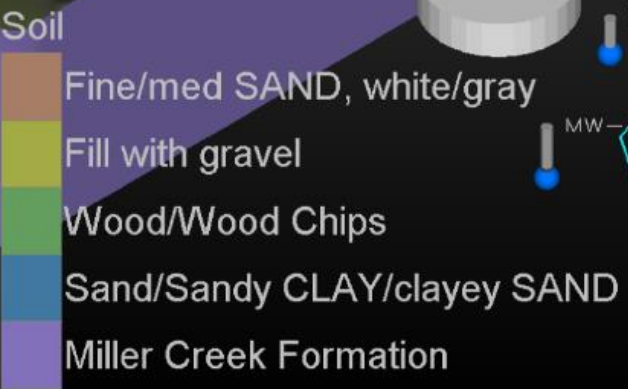
# RI Results – Benzene in Subsurface Soil

Soil Benzene Samples Below 4 ft.  
and Impacts > 100 mg/Kg

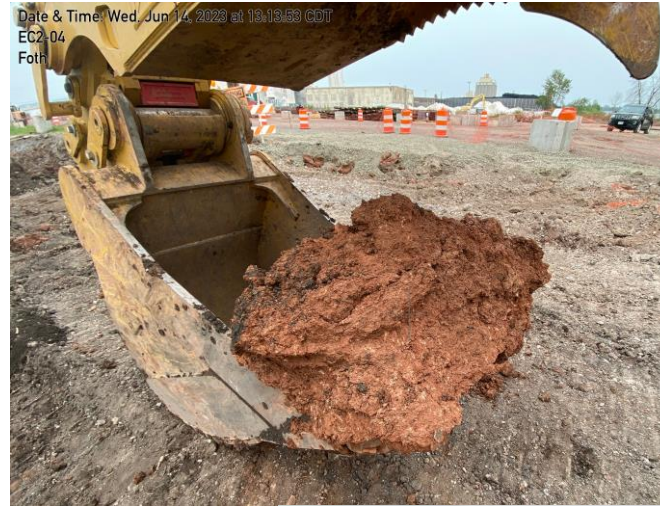
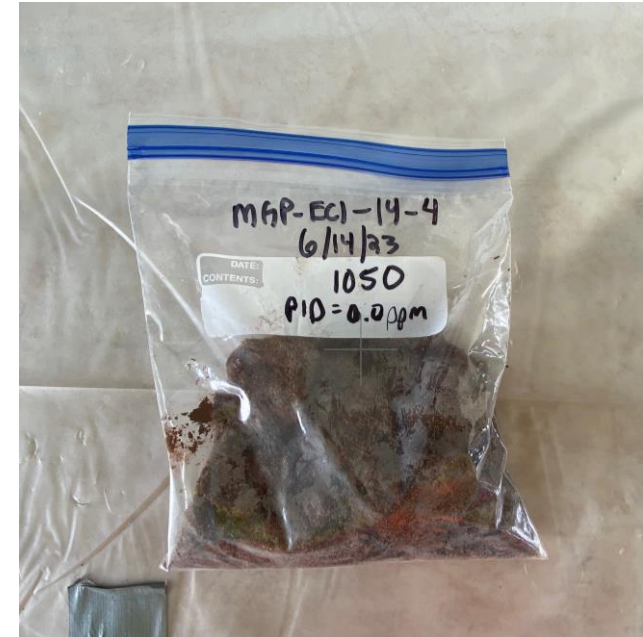
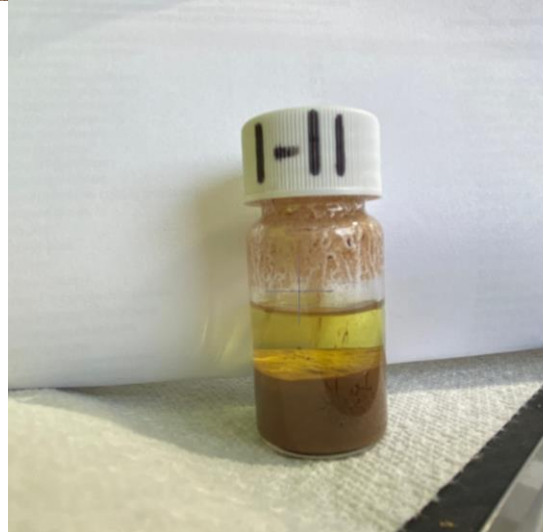
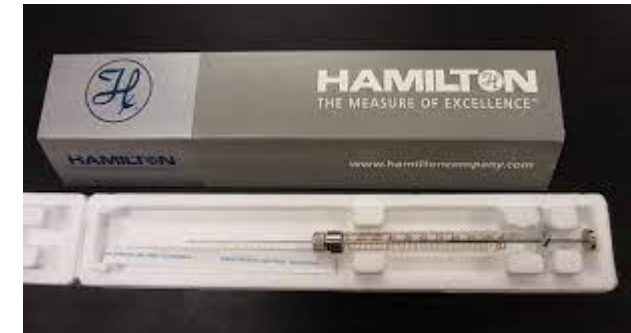
# Remedial Action Completion

Confirmation soil samples field screened with Frog 5000 field GC

Remedial excavation extents adjusted to find clean end points

Biosparge system design was flexible, adjusted to observed site conditions
