# Fractured Rock Groundwater Conceptual Site Model

## Diabase and Sandstone Contact in a Basin-Edge Context

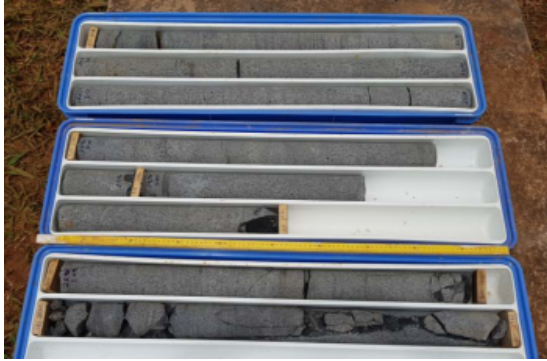
Abstraction well PP-05 indicated diabase from 6,0 to 102 mgl;

- Silt and sandstone from 102 to 132 mgl;
- Gneiss from 132 to 180 mgl;

Borehole S-01 indicated diabase from 20.9 to 27.7 mgl (max depth).

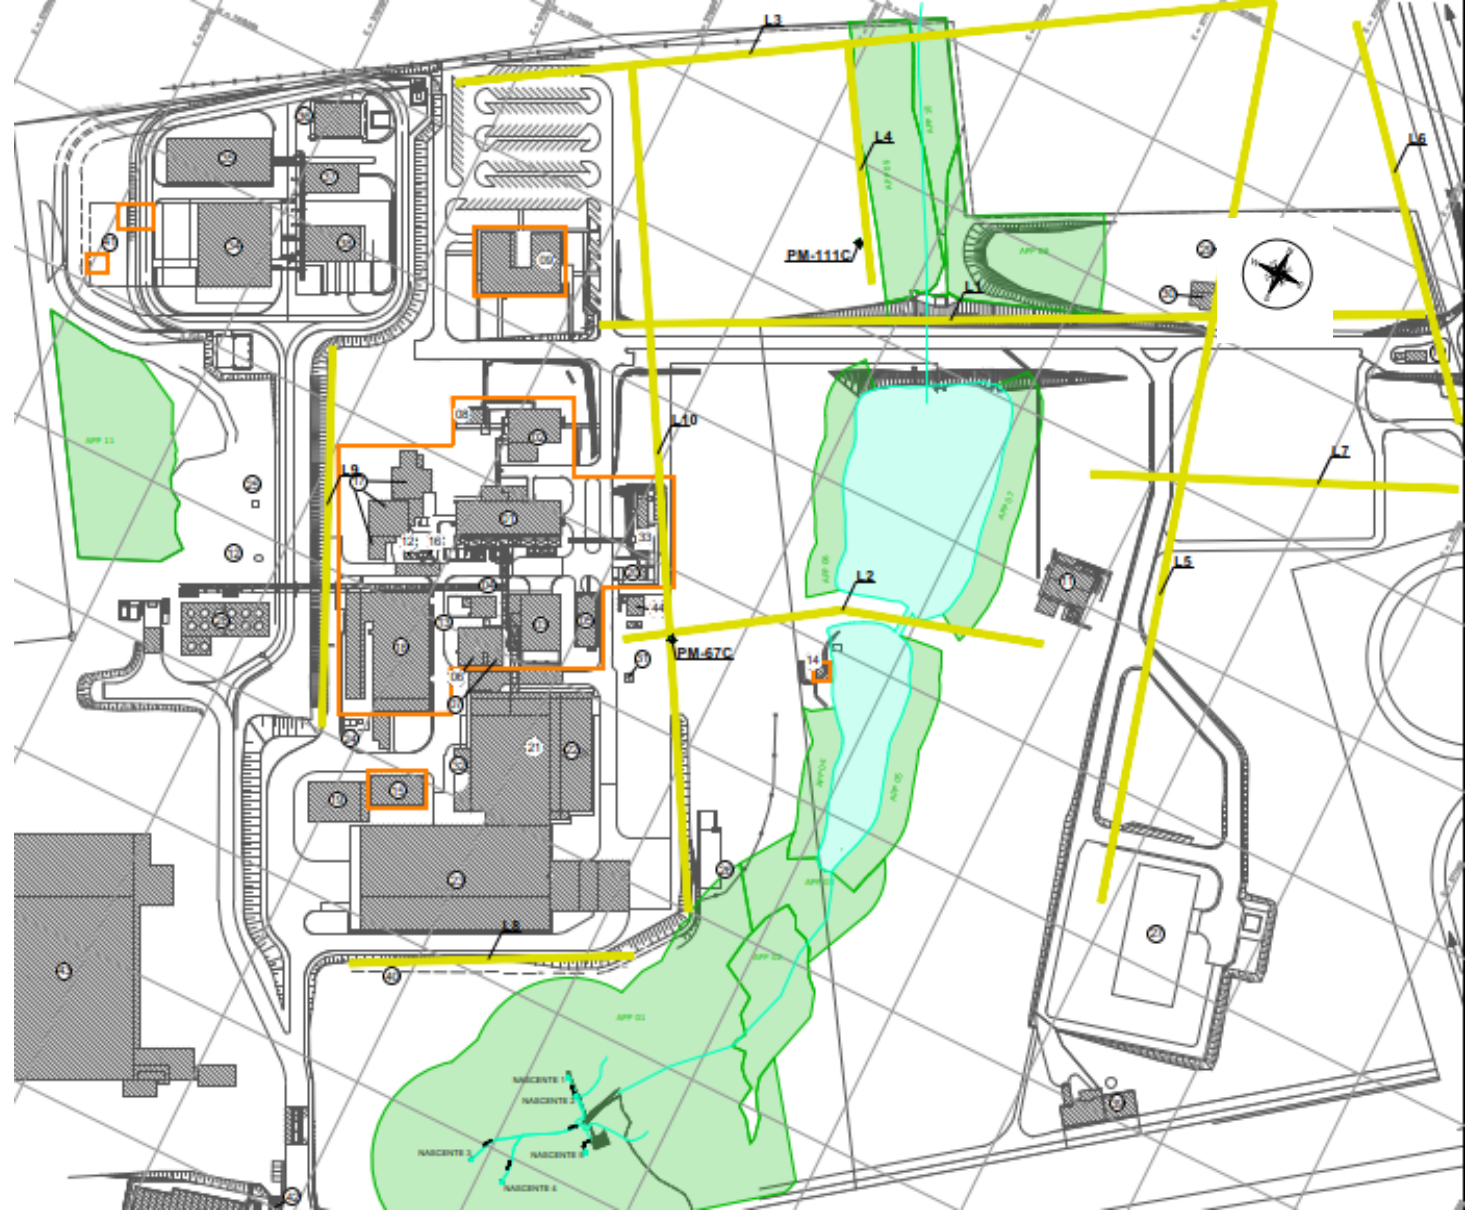
— DPR Survey Lines

# Deep Penetrating Radar (DPR) Survey

- Able to map down to 70mbgl in high definition;
- 25 MHz transmitter and 50 MHz receptor;
- Survey on 11 lines;
- 3D CSM development

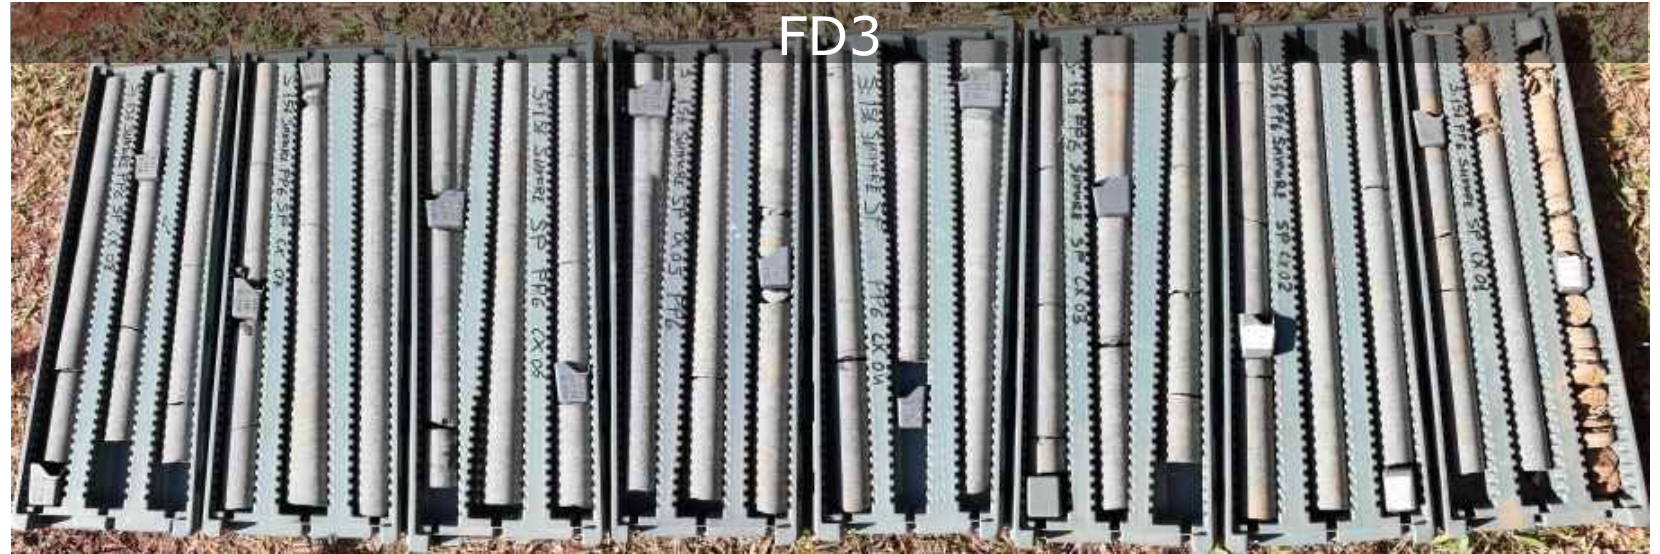
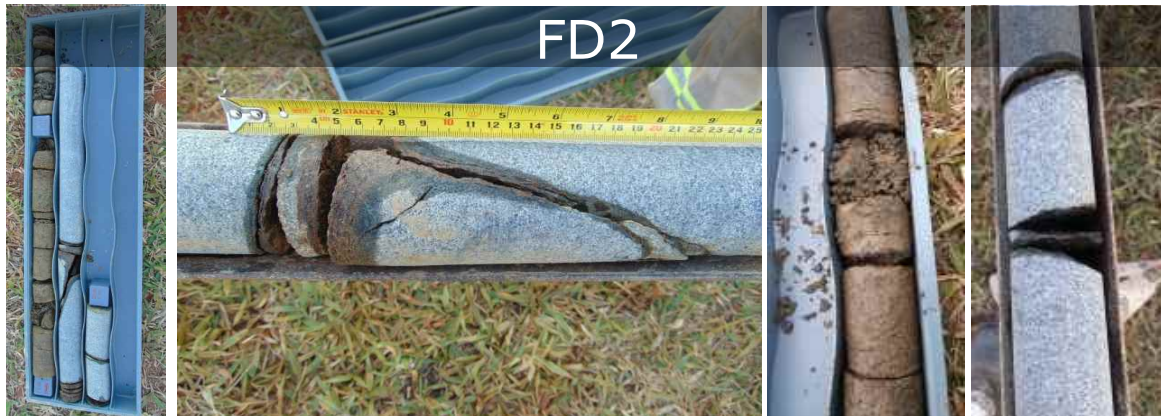
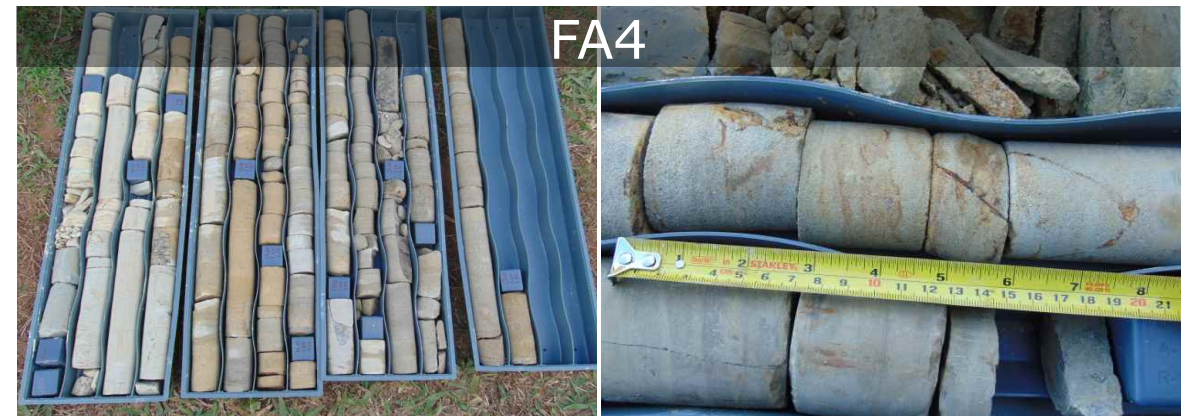
# Borehole Drilling

Presence of diabase where sandstone was expected (FA5).

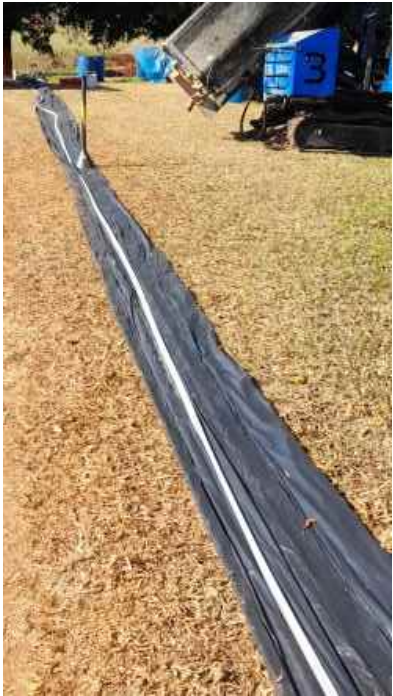
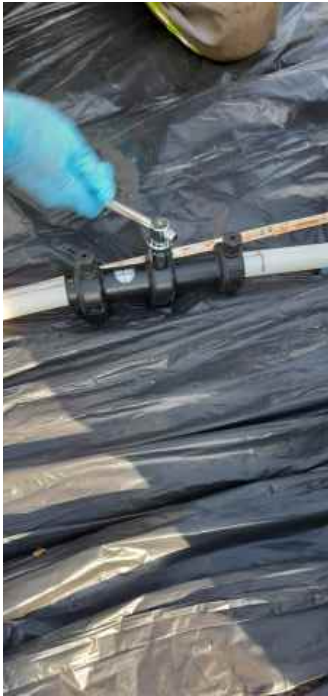
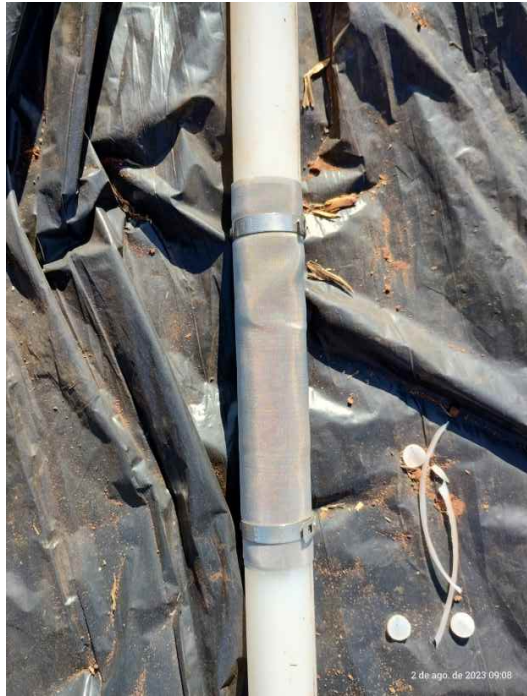
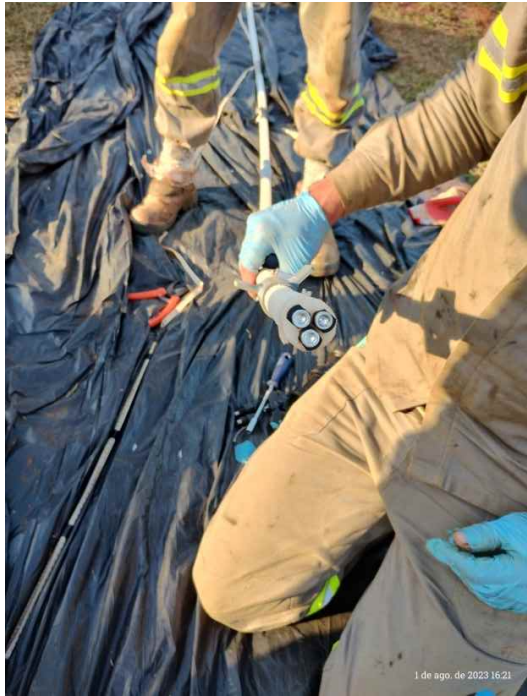
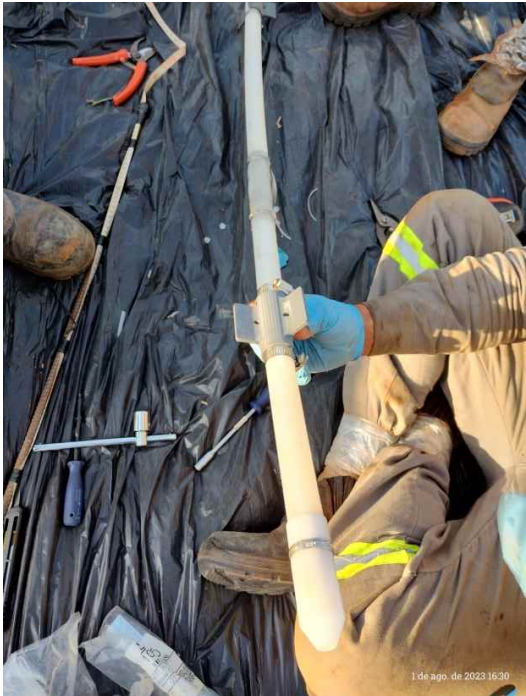
# CMT® Monitoring Well Installation

| Monitoring Well | FD2 | FD3 | FA4 | FA5 |
| Channel 1 (m) | 17,7 | 22,3 | 13,5 | 15,5 |
| Channel 2 (m) | 18,7 | 24,7 | 16,5 | 17,0 |
| Channel 3 (m) | 19,7 | 48,0 | 23,0 | 20,8 |
