# From Bench Test to Full-Scale Remedy – Combining ZVI with Bioremediation to Treat Mixed VOCs in a Low-Permeability Formation

Chapman Ross, P.E. – FRx, Inc. – [cross@frx-inc.com](mailto:cross@frx-inc.com)

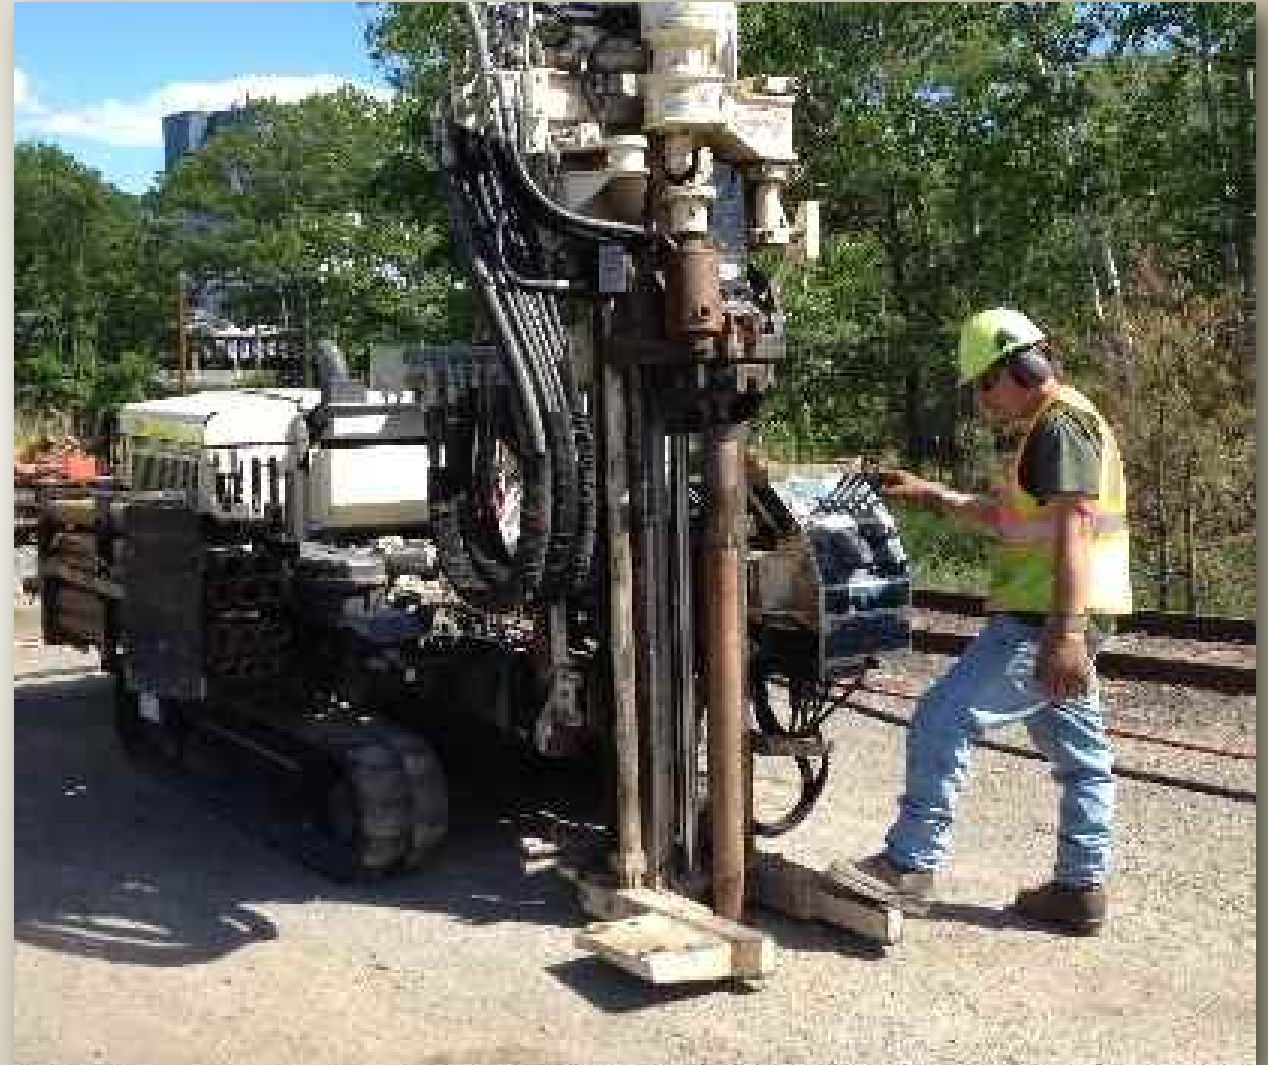
# Controlled Hydraulic Fracturing Methods

- Traditional DPT
- DPT Jet Injection
- Cased-Hole Jet Fracturing

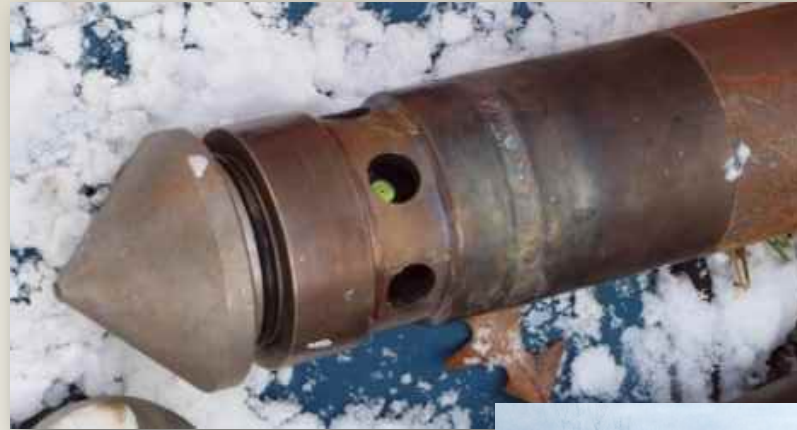
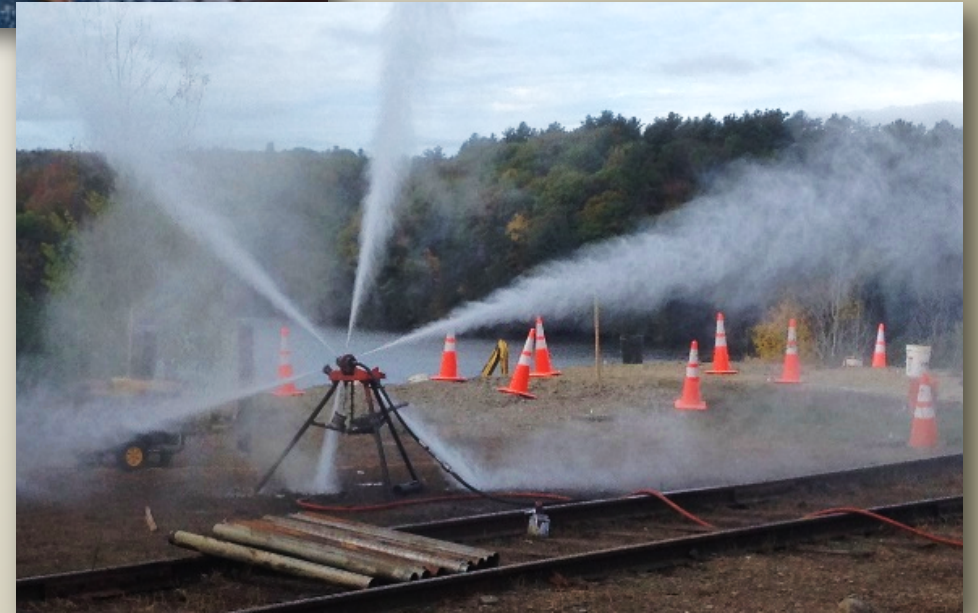
# Controlled Hydraulic Fracturing Methods

- Traditional DPT
- DPT Jet Injection
- Cased-Hole Jet Fracturing

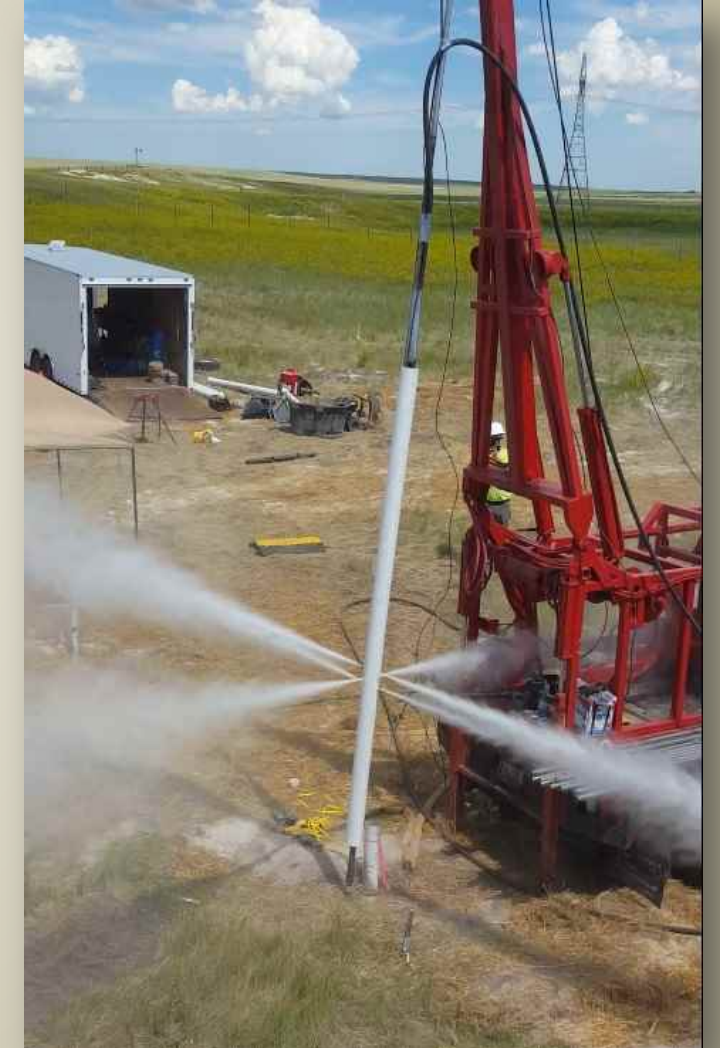
# Controlled Hydraulic Fracturing Methods

- Traditional DPT
- DPT Jet Injection
- Cased-Hole Jet Fracturing

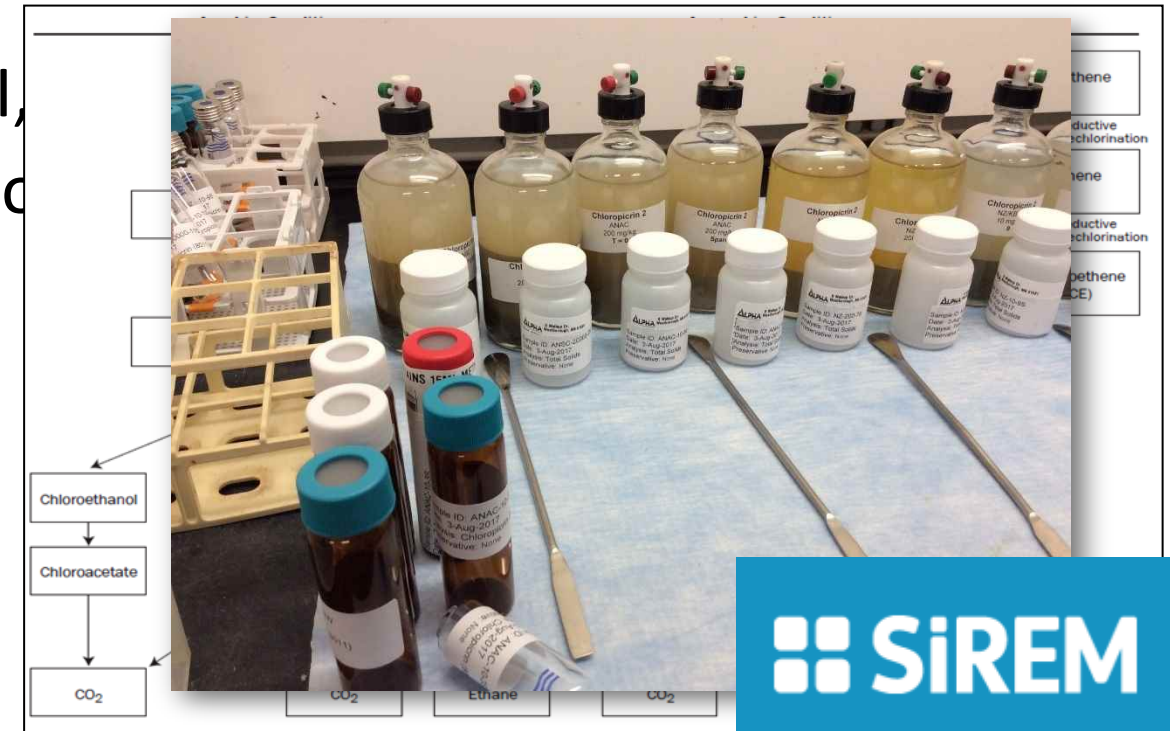
# Bench Test Findings

- Mixed VOCs that degrade under different mechanisms.
- Testing evaluated a range of mZVI materials with and without electron donors and included bioaugmentation with *KD 1® Plus*
